HEDDERMAN ENGINEERING, INC.

REF: CONDITION OF PROPERTY SURVEY

At your request, a visual survey of the foundation of the house located at , Houston, Texas was made by Mr. Tim Hedderman.

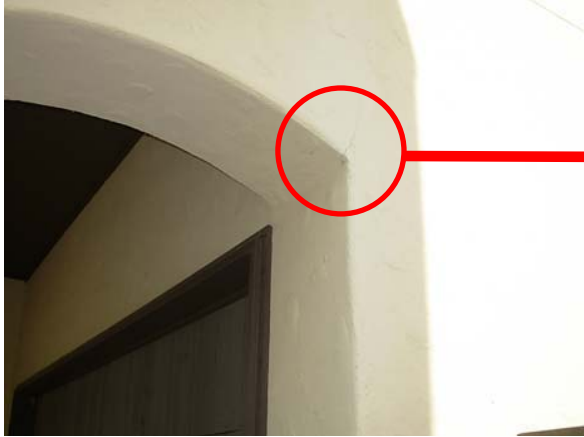
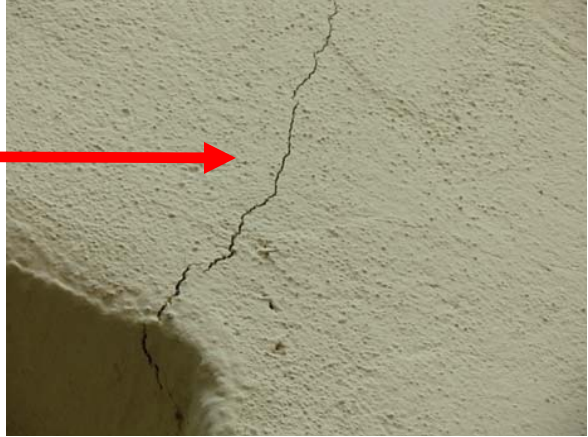
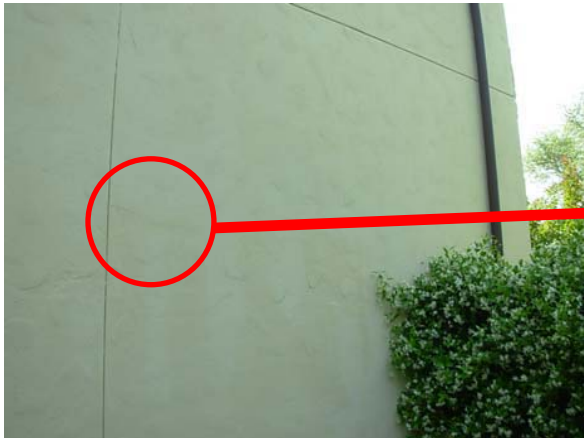
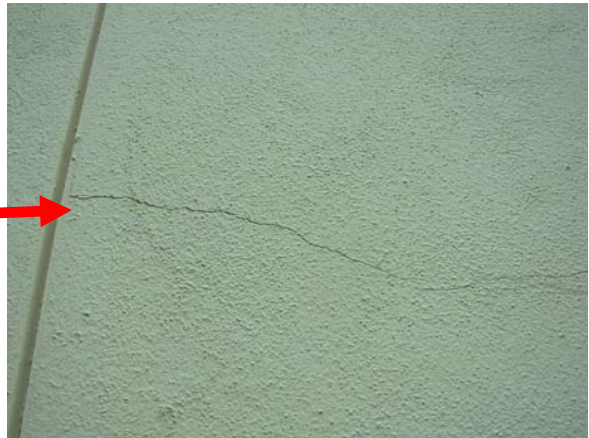
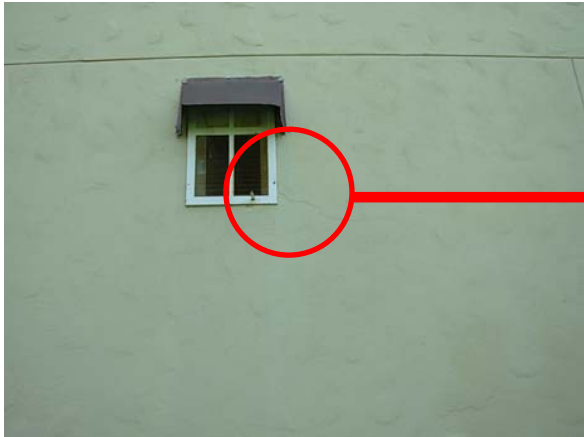
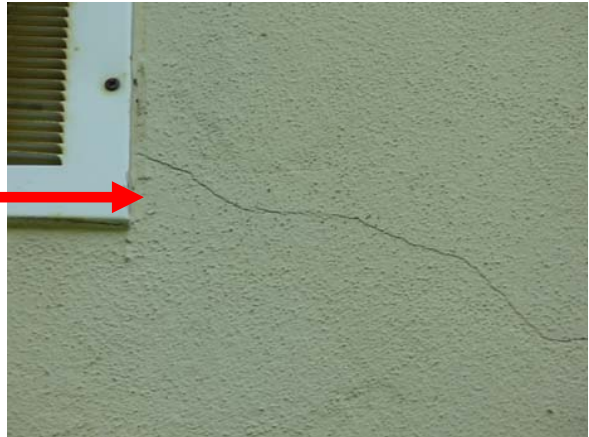
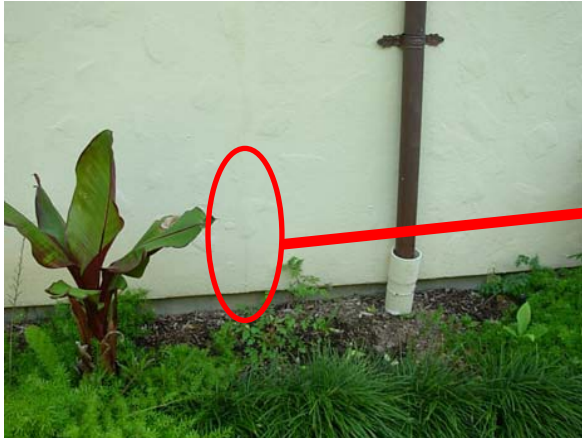
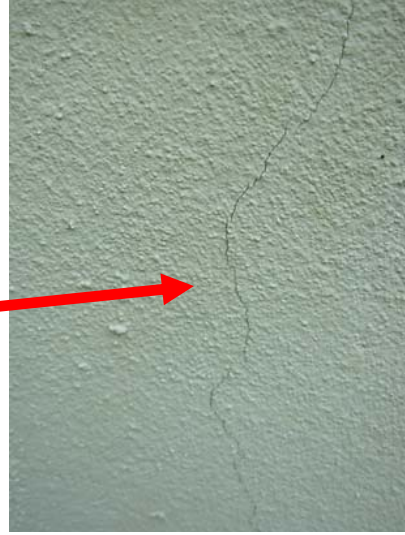
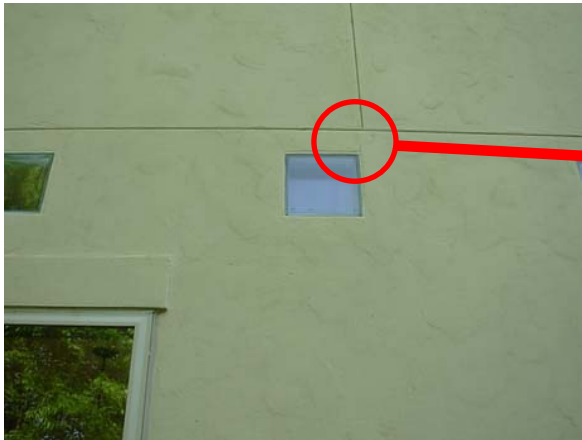
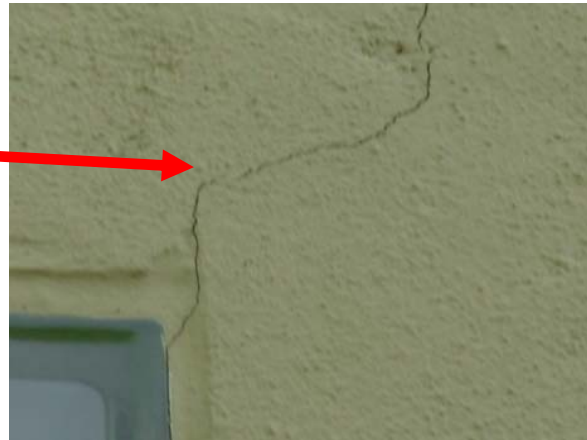
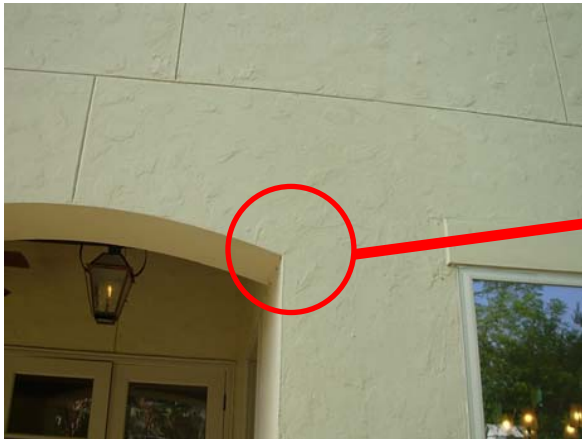
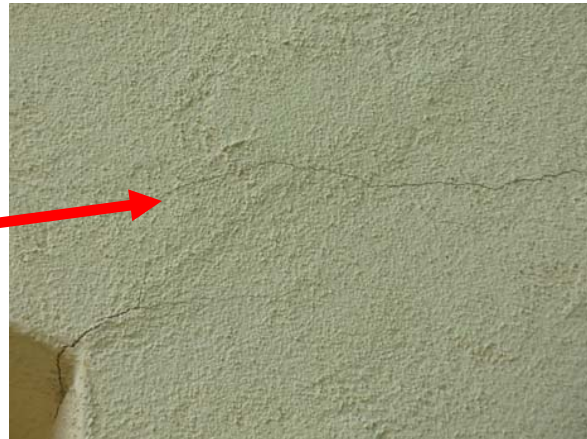
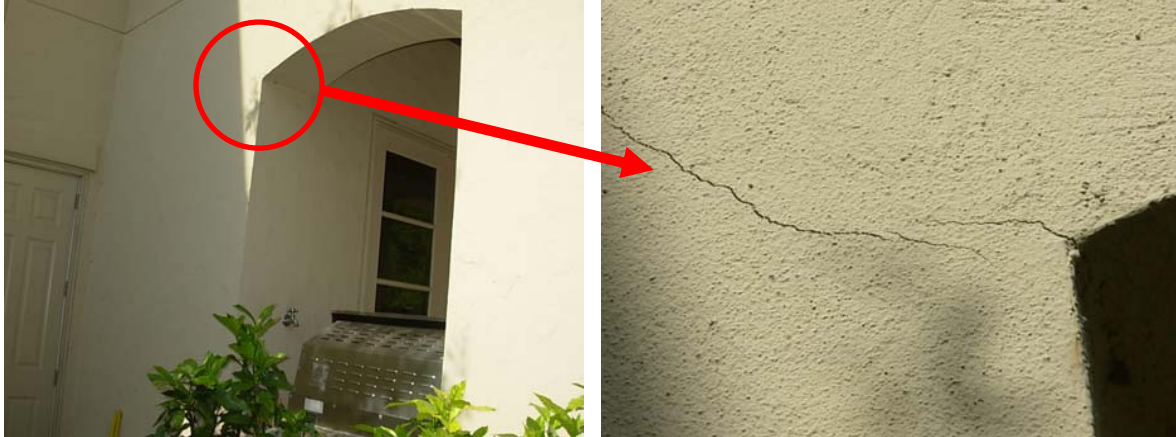
- * Cracks and/or patches were observed in the exterior stucco veneer at all four sides of the house, as seen in the photos below. The cracks in the stucco were in accordance with movement of the foundation as seen in the elevation survey at the end of the report.

Due to the more than acceptable amount of movement of the foundation of this structure, it is our opinion that releveling of the foundation is needed at this time. It is recommended that at least three foundation repair contractors be contacted in order that they may make their own assessment of the scope and cost of the work needed to bring this foundation back to an acceptable degree of levelness.

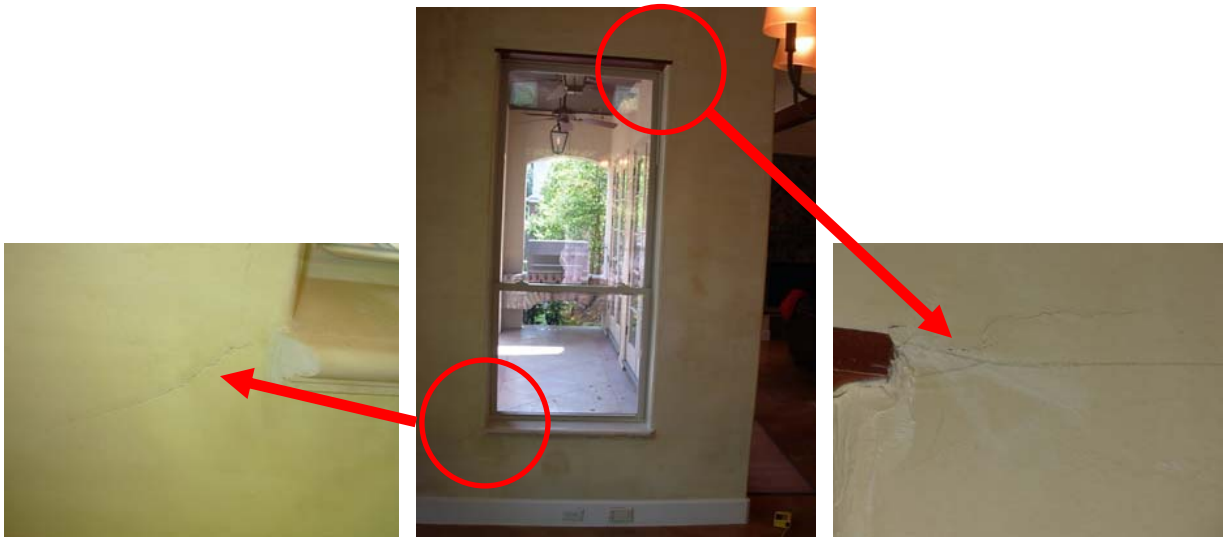
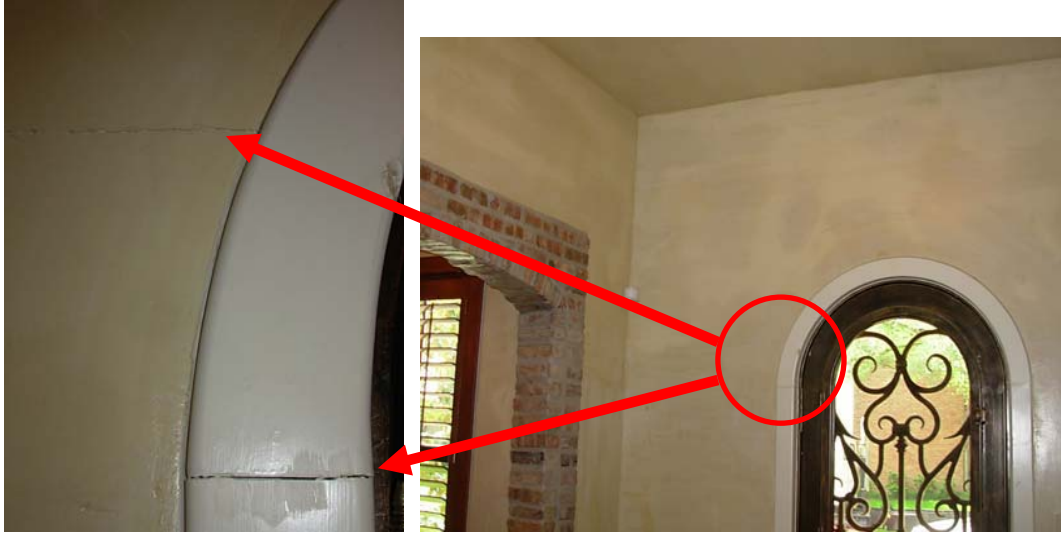
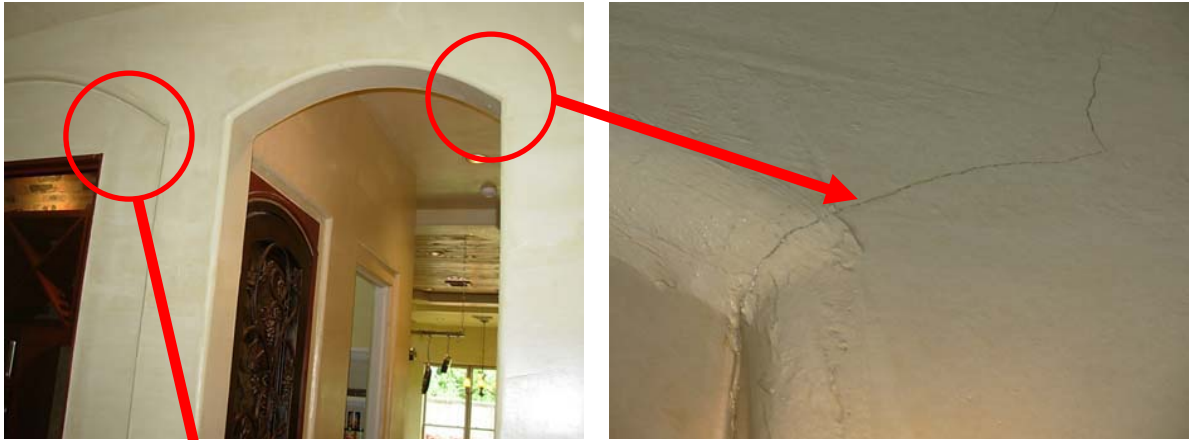
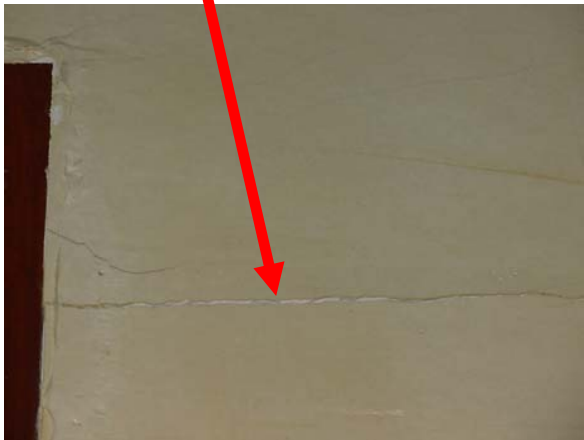
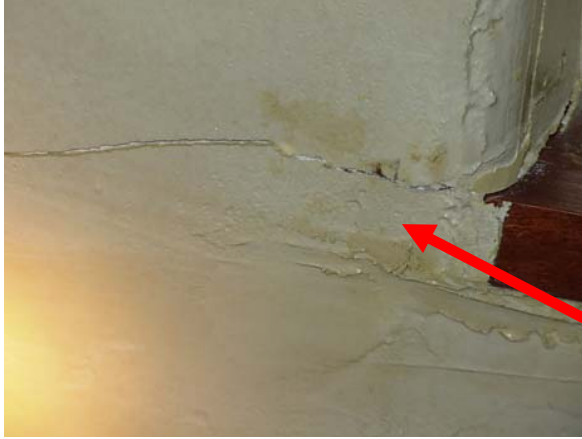
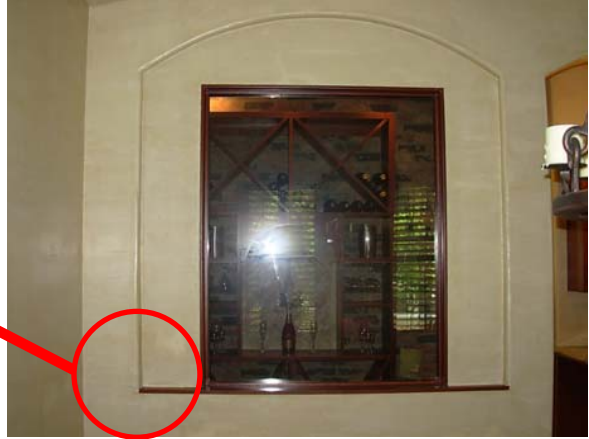
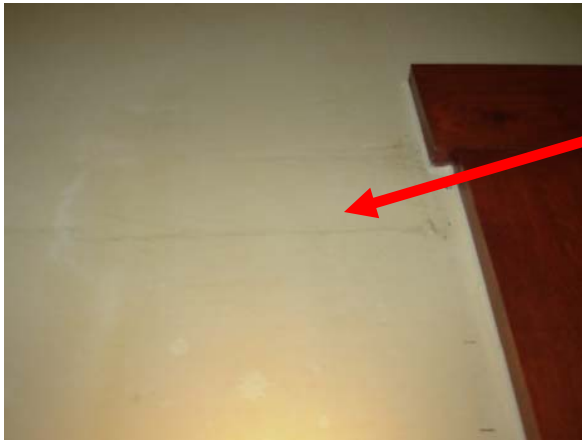
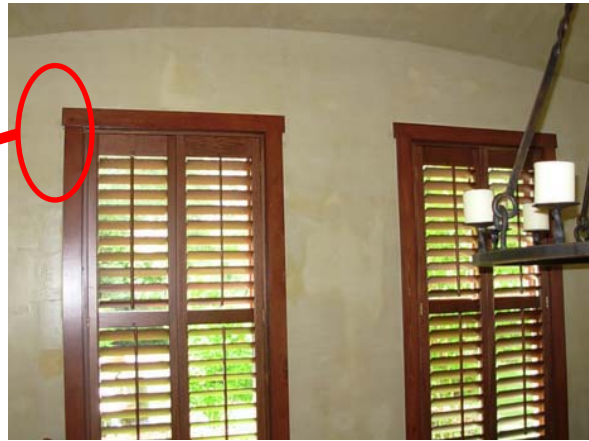
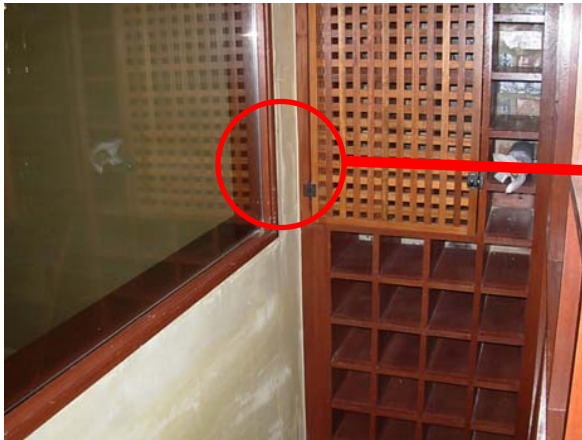
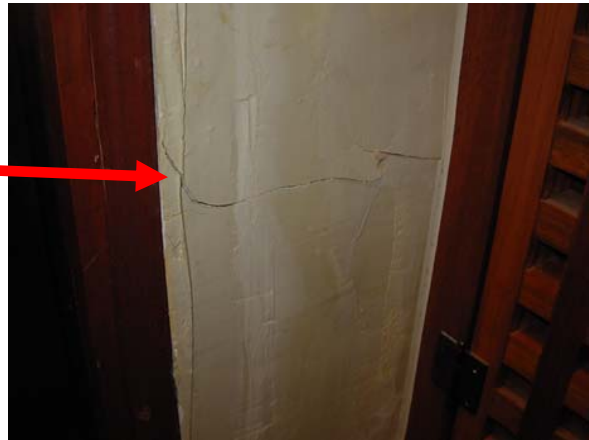
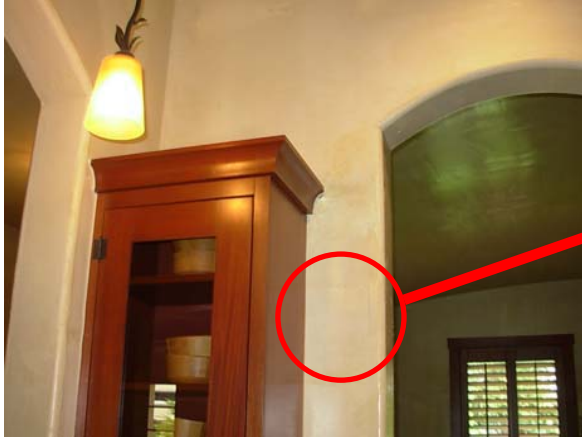
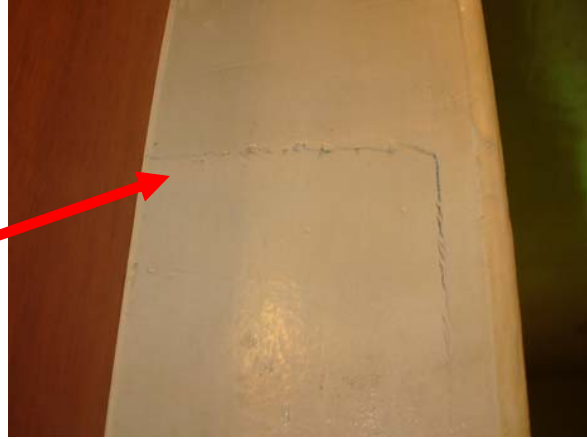
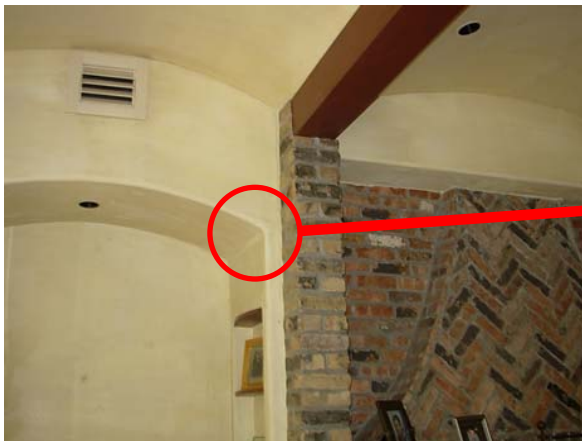
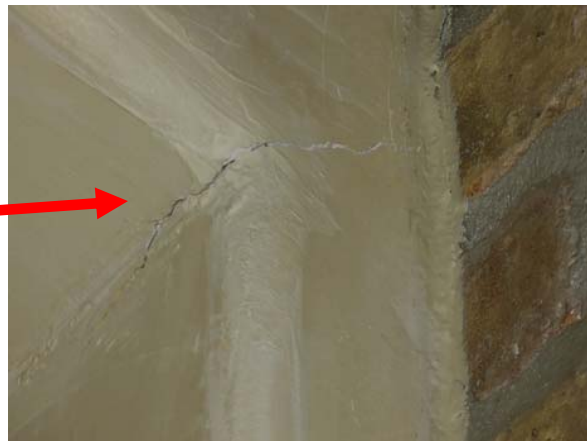
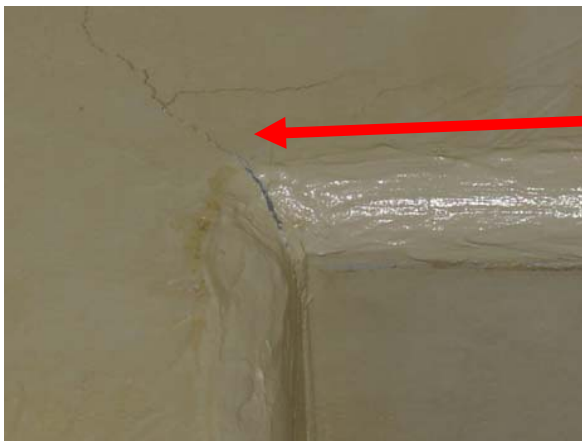
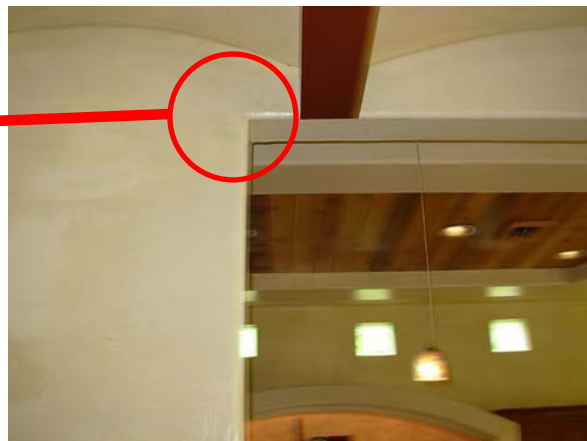
- * Sheetrock cracks, patches, or compression ridges were observed several locations as seen in the photos below. The location and direction of the cracking is in agreement with the sloping of the floors to indicate settlement of the foundation towards the low area of the house at the front wall of the study. Note that the following is only some, not all, of the cracks observed in the house.

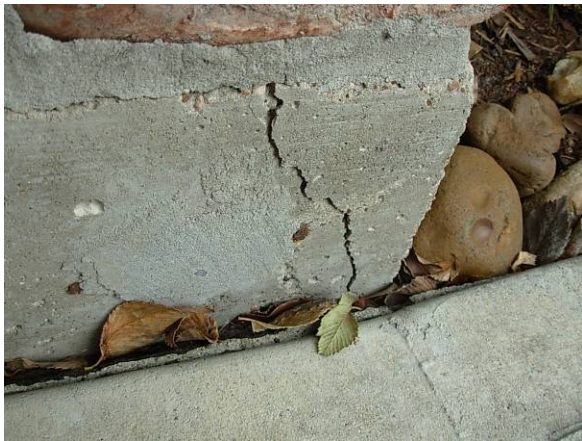
The corner of the foundation was observed to be chipped. This is condition that is caused by differences in thermal expansion between the brick veneer, and the concrete foundation. Also, this condition can be caused by a lack of reinforcement in the corner of the foundation during original construction. In our opinion, this condition does not affect the structural integrity of the foundation.

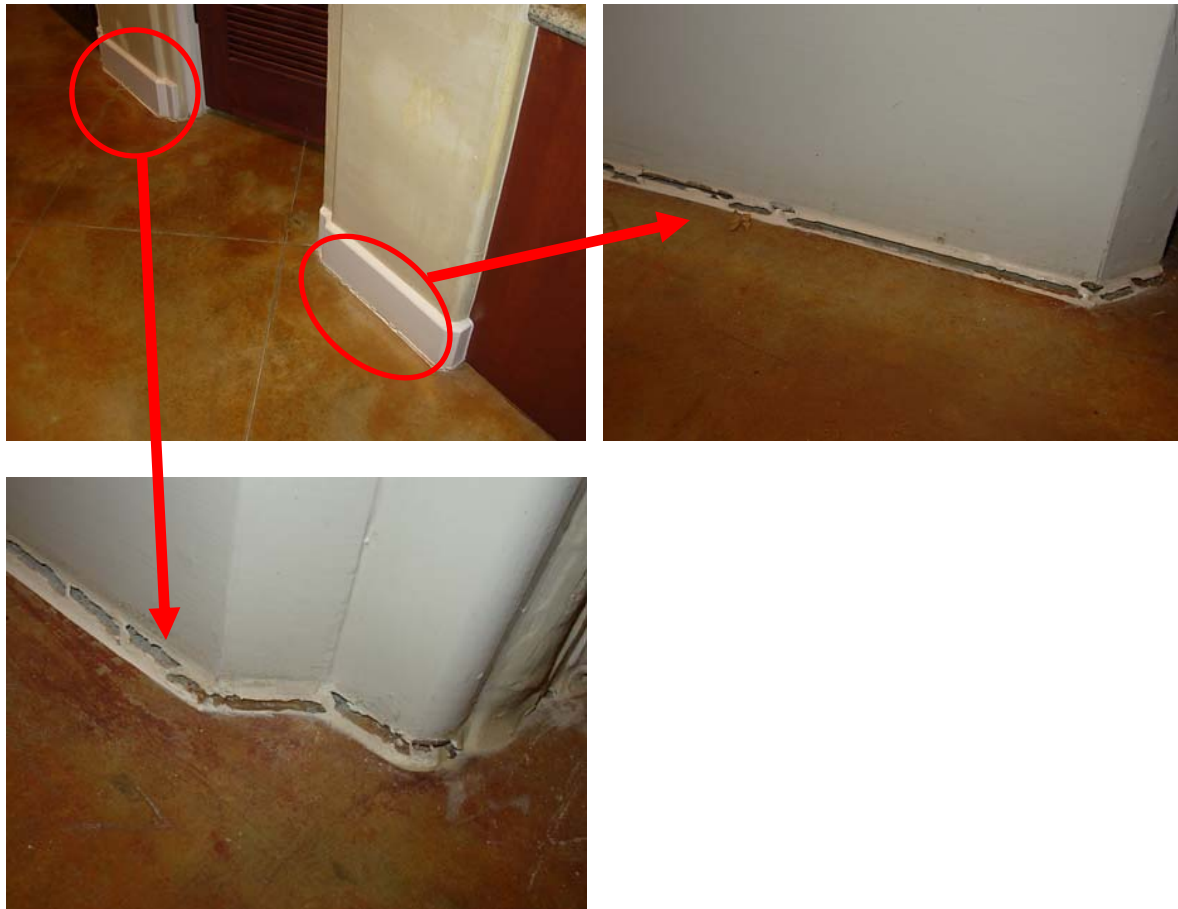
- A separation was visible at the bottom of the door trim at the kitchen pantry and wine room area.

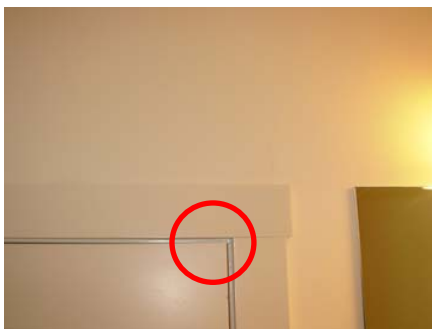
- A door was sticking at the upstairs west center bathroom.

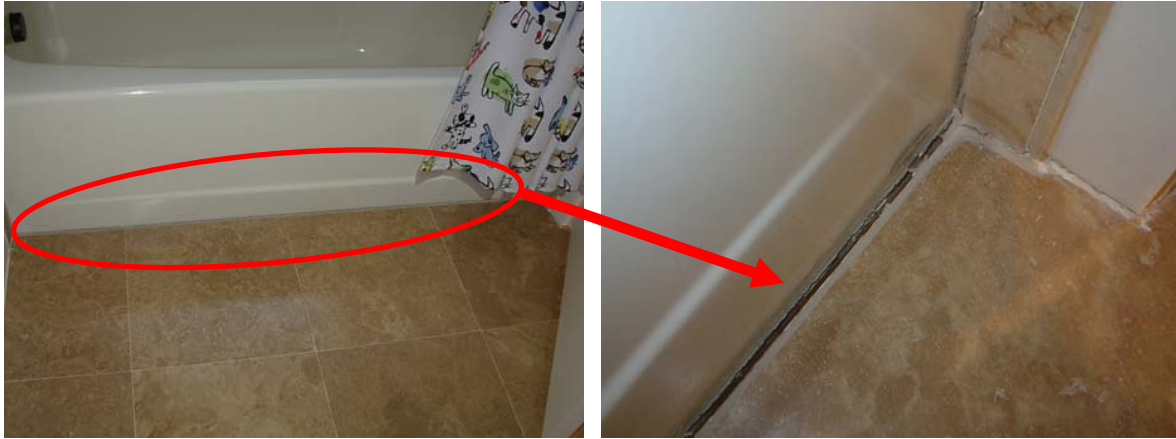
- The floor tiles at the upstairs west center bathroom were separated from the edge of the tub.

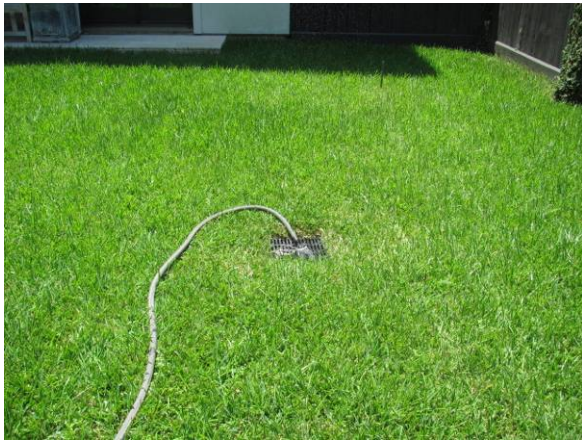
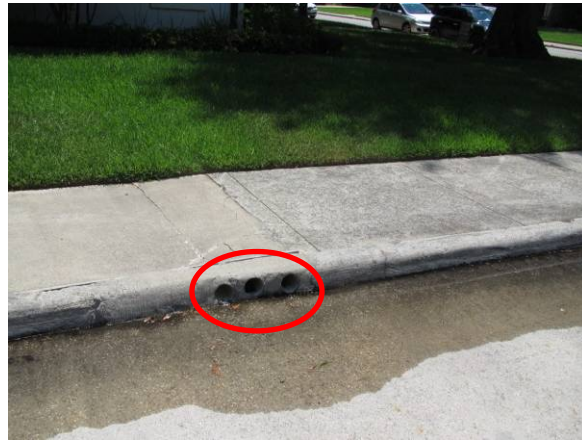
The underground drainage system at the rear of the house was checked by running water into the drain for approximately 15 minutes, and the system was observed to be draining properly to the street.

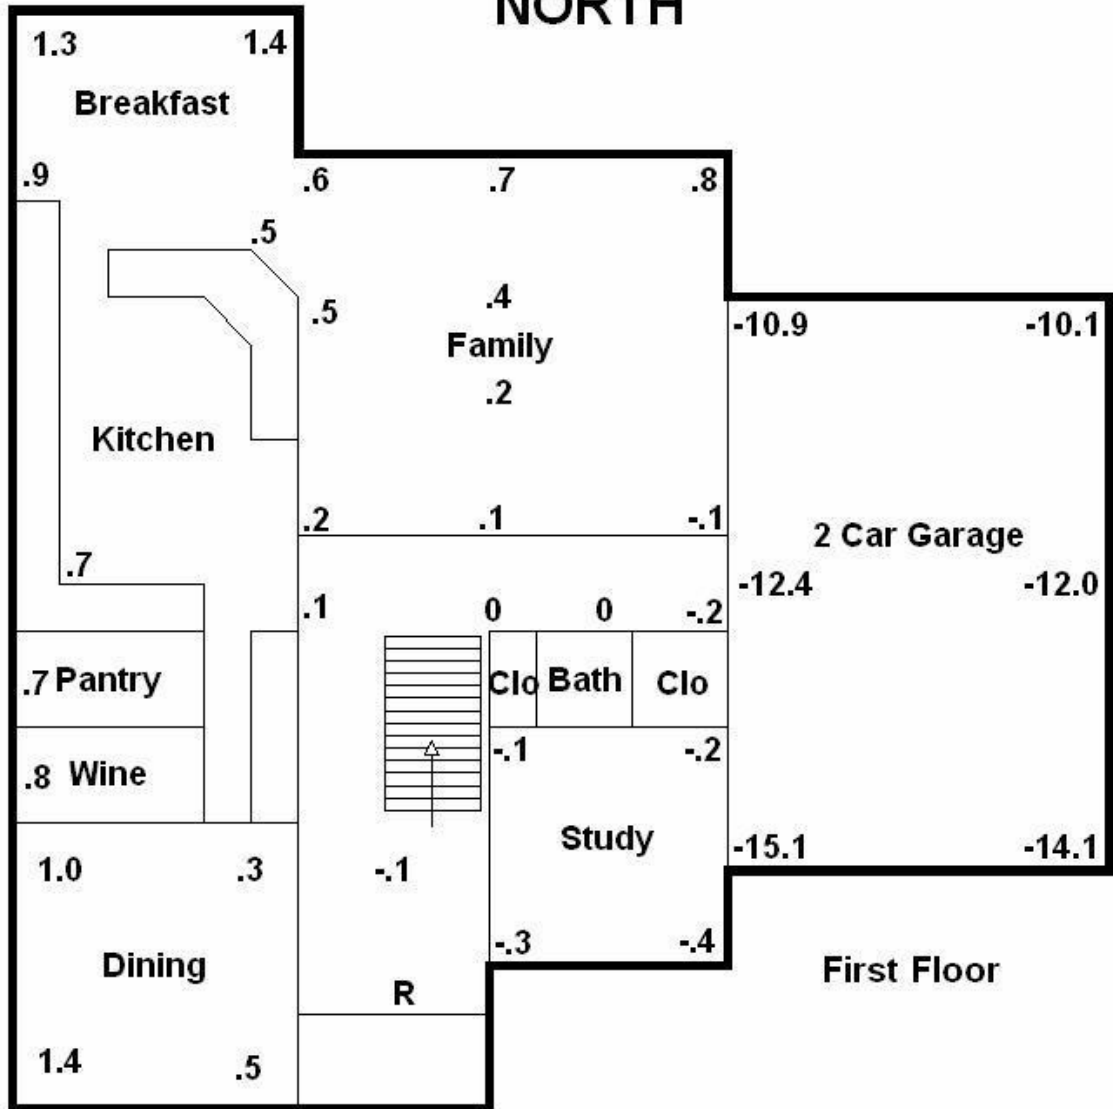
ELEVATION READINGS

- * Normally horizontal surfaces, such as floors, door tops, counters, window sills, etc., were observed to be sloping generally from the rear of the house towards a low area at the front wall of the house at the study. The floors were checked with an electronic level, and the difference in elevation between the high point and low point was 1.8 inches on the first floor and 2.2 inches on the second floor.

See our field sketch showing the elevation readings at the end of this report. Note that the "R" on the sketch is our randomly chosen starting reference point, where the elevation is 0, and all other elevation readings are taken relative to the reference point, and are measured in inches to the nearest 1/10 inch. Note also that elevation readings taken at the garage area are relatively large numbers relative to the reference point due to the step down into the garage area.
