HEDDERMAN ENGINEERING, INC.

REF: CONDITION OF PROPERTY SURVEY - Foundation.

At your request, I made a visual survey of the foundation of the house being constructed at , Houston, Texas.

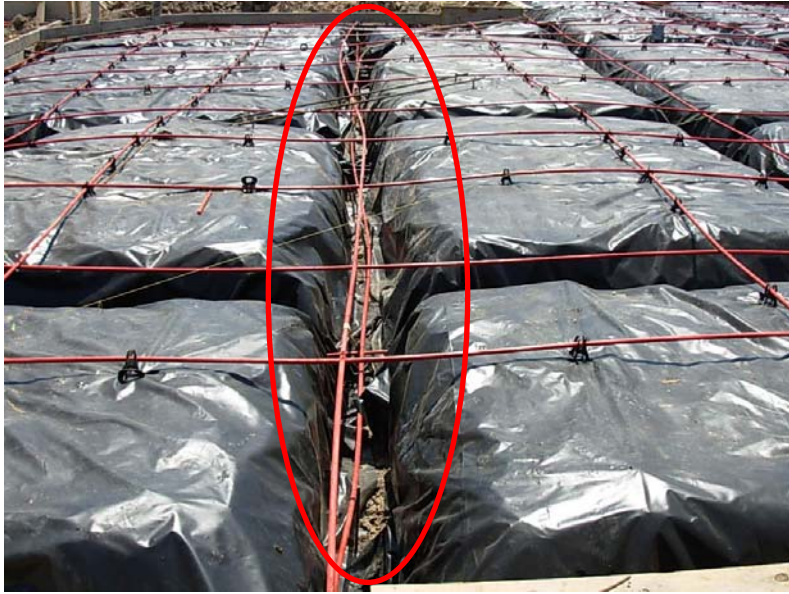
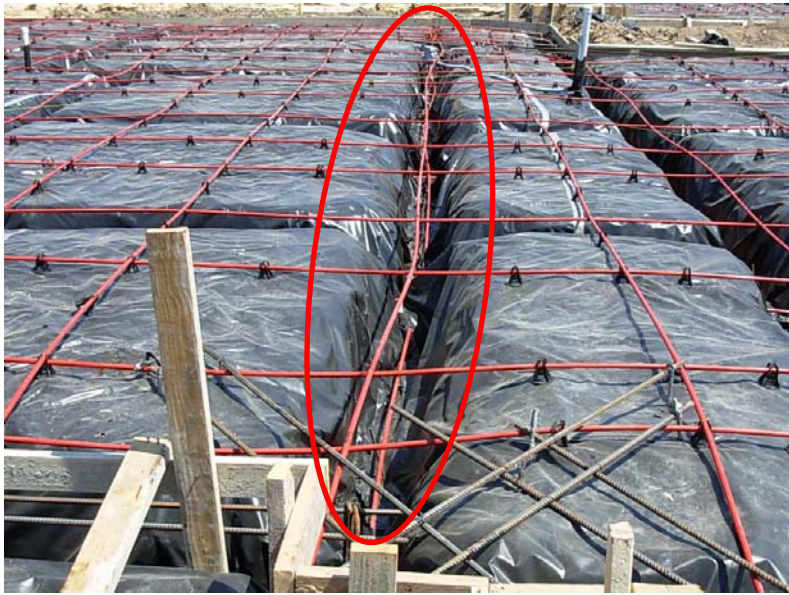
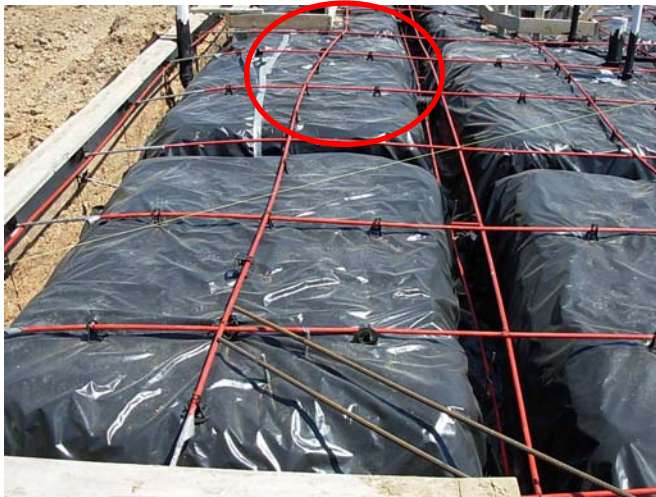
1. We observed that the drawings showed that the depth of the grade beams should be 16 inches. We checked the depth of the beam at several locations around the perimeter, and everywhere we checked, the depth was 26 inches.
2. Several of the tendons were not installed straight, but with curves in the tendons. When the tendons are stressed with approximately 33,000 pounds of pulling force, the curves will have a tendency to straighten out, introducing stresses into the slab. It is pointed out that these curves in the tendons are not the normal curves in the tendons for the interior and perimeter grade beams. Rather, these curves are typically from side to side in an "S" shape. The tendons need to be adjusted so that they are essentially in a straight line. (see photos below)

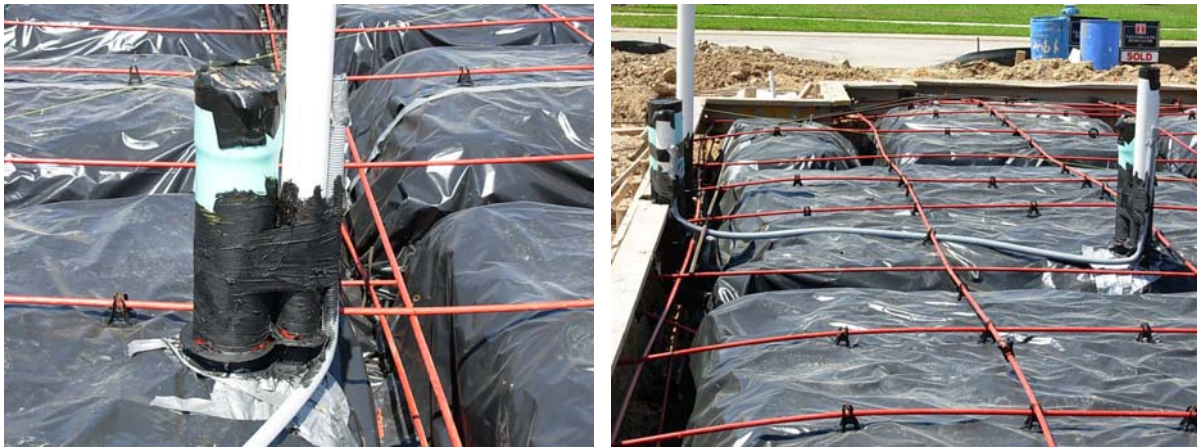
3. The PVC piping has been properly coated with mastic to break the bond between the PVC and the concrete.

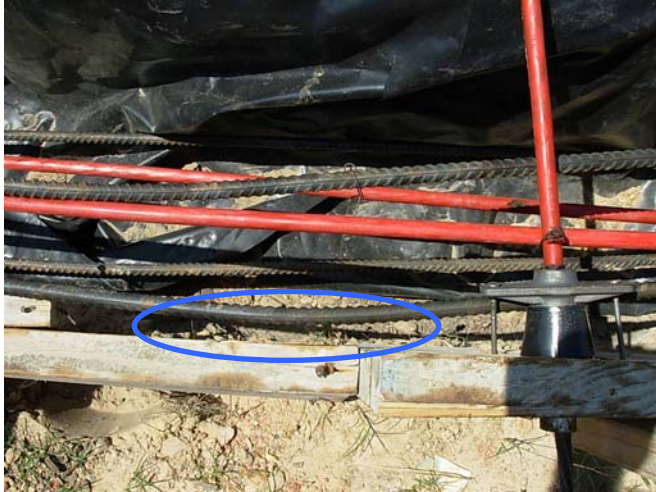
4. The rebar was generally installed in a workmanlike manner, with adequate ties and support, and proper clearances to the sides of the forms. One exception to this was observed at the rear beam, where the rebar had only one inch of clearance to the side of the form, rather than the required two inches.

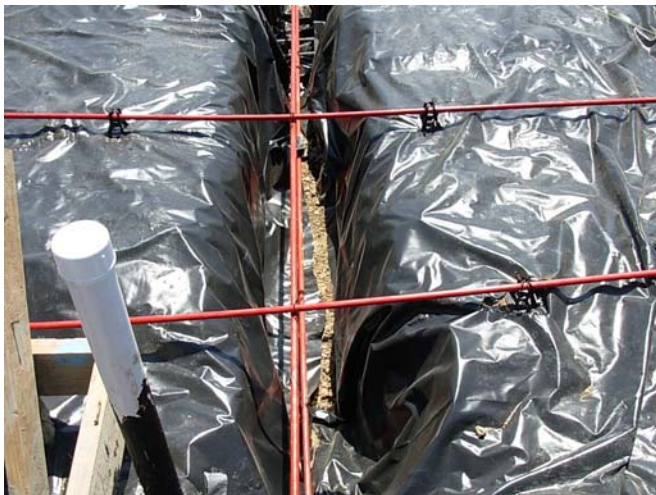
5. The plastic vapor barrier had a gap at the bottom of one of the grade beams, where dirt was visible due to the plastic not being lapped. An additional piece of plastic needs to be installed across the bottom of the beam.

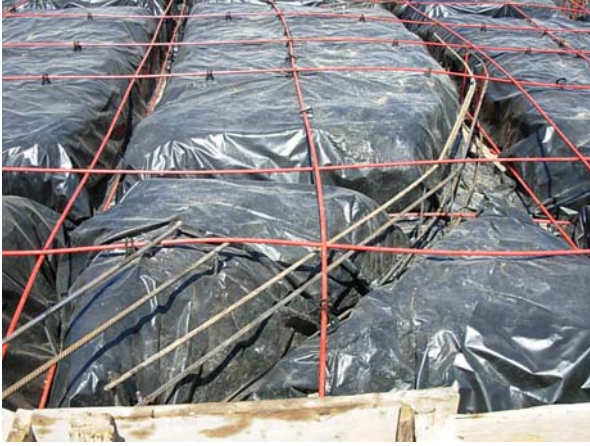
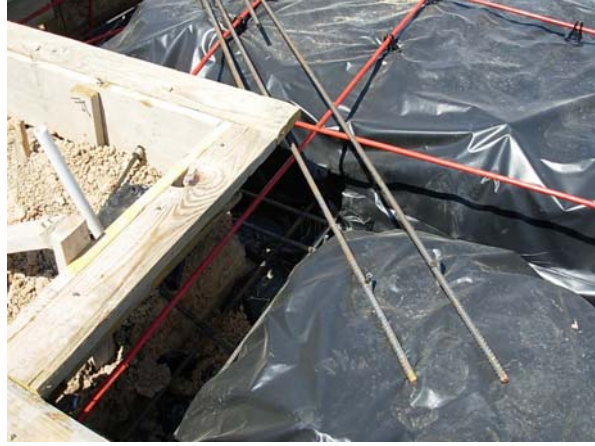
6. The reinforcing steel has been installed in the concrete grade beams and at corners, where bars have been installed at a 45 degree angle to corners. (see photos below)

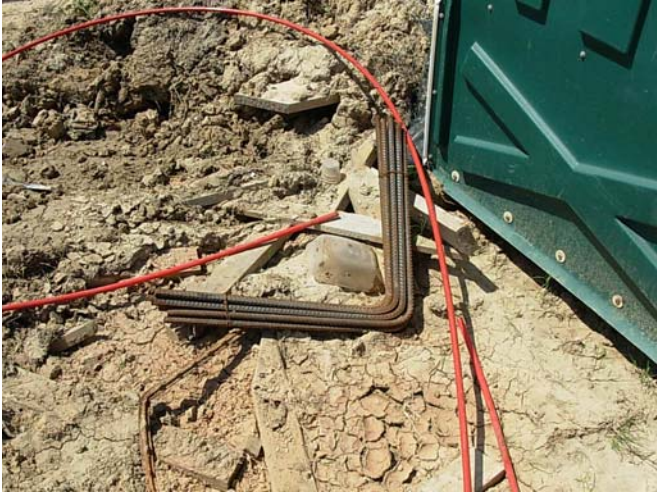
7. We observed a bundle of corner rebar that has apparently not been opened, and obviously not installed. Further investigation with your builder concerning the bars is recommended. (see photo below)

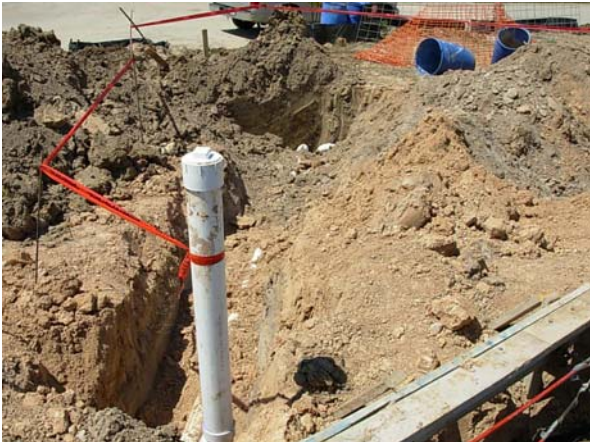
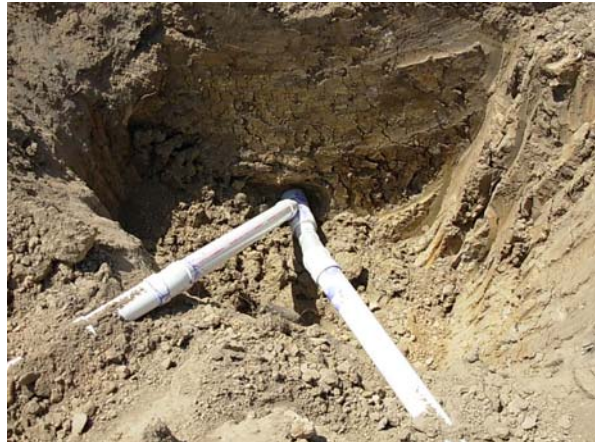
8. The underground sewer piping has been installed.
