HEDDERMAN ENGINEERING, INC.

At your request, I made a visual survey of foundation of the house located at , Houston, Texas.

Transmitted herewith is the inspection report stating my professional opinion on whether the foundation is performing its intended function, or is in need of repair.

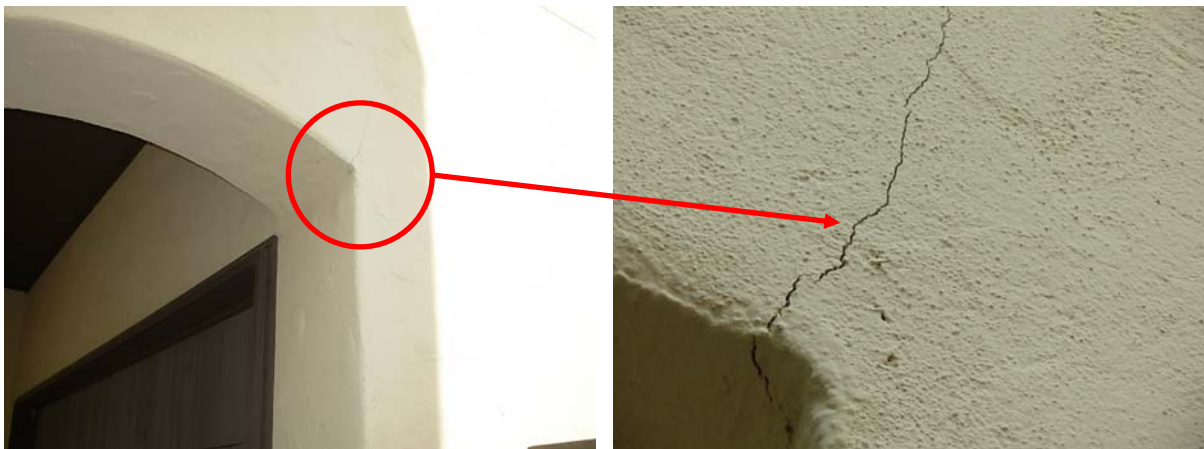
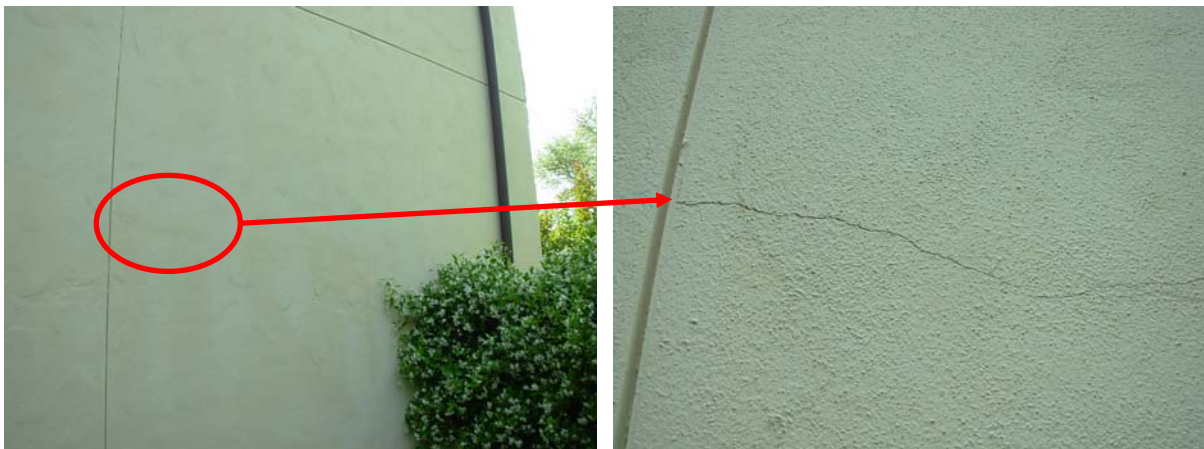
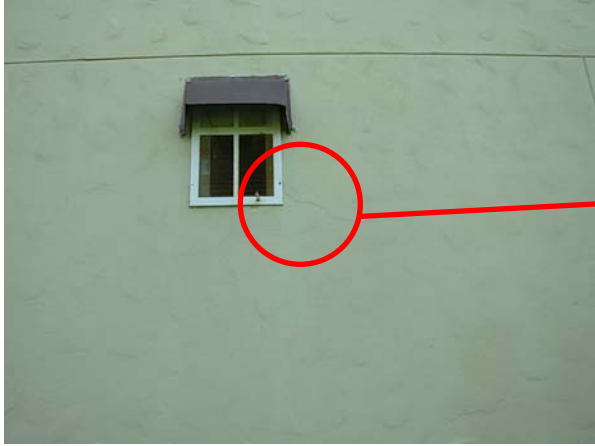
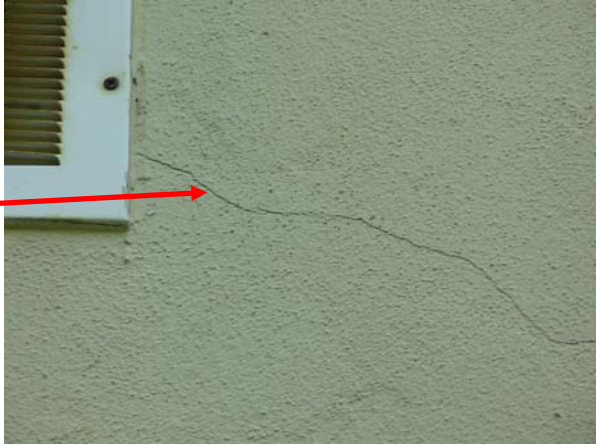
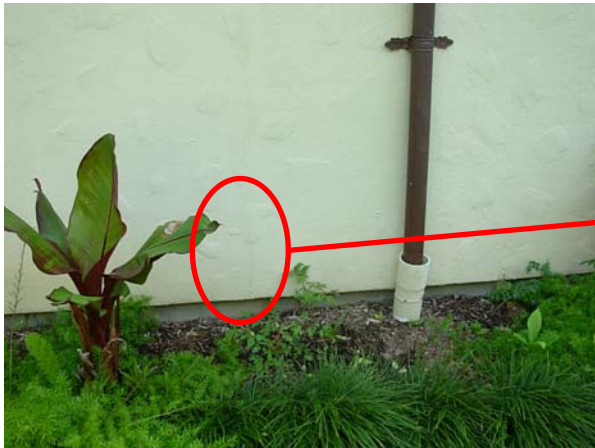
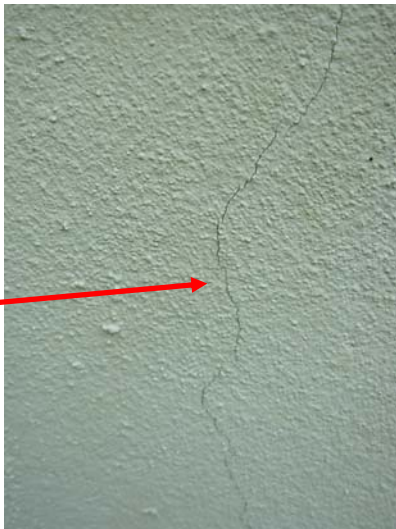
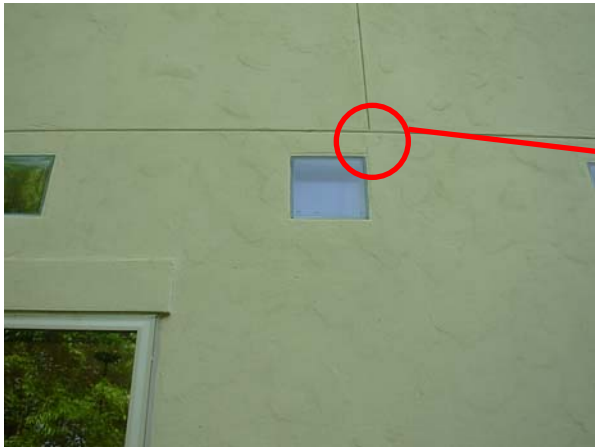
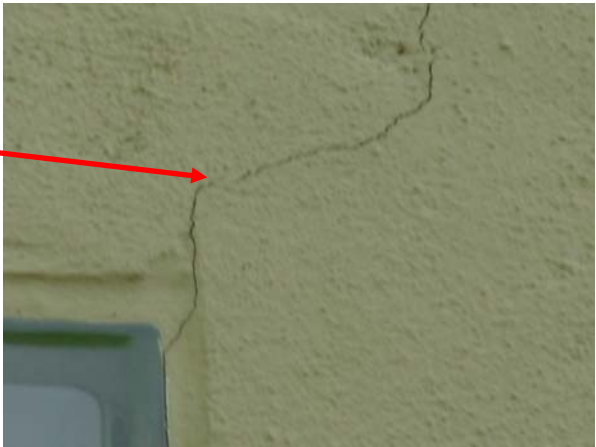
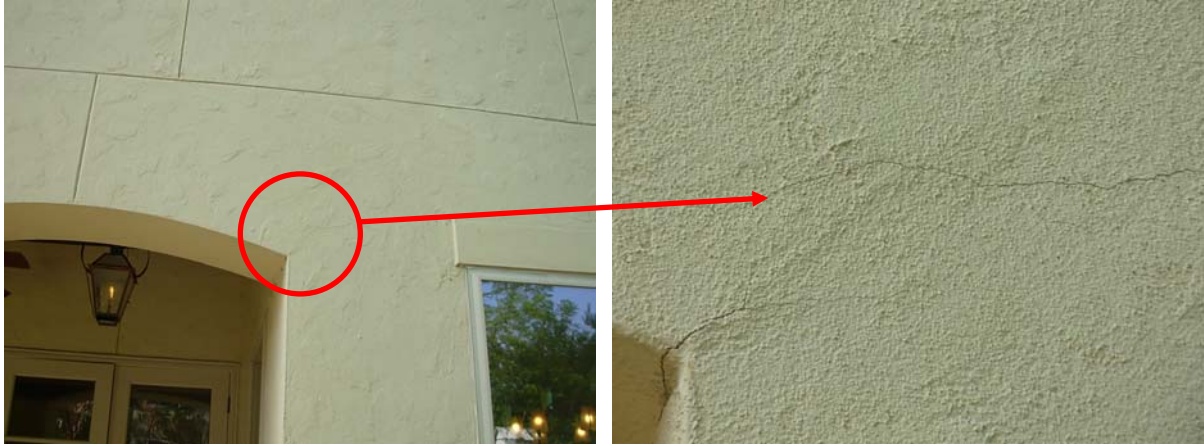
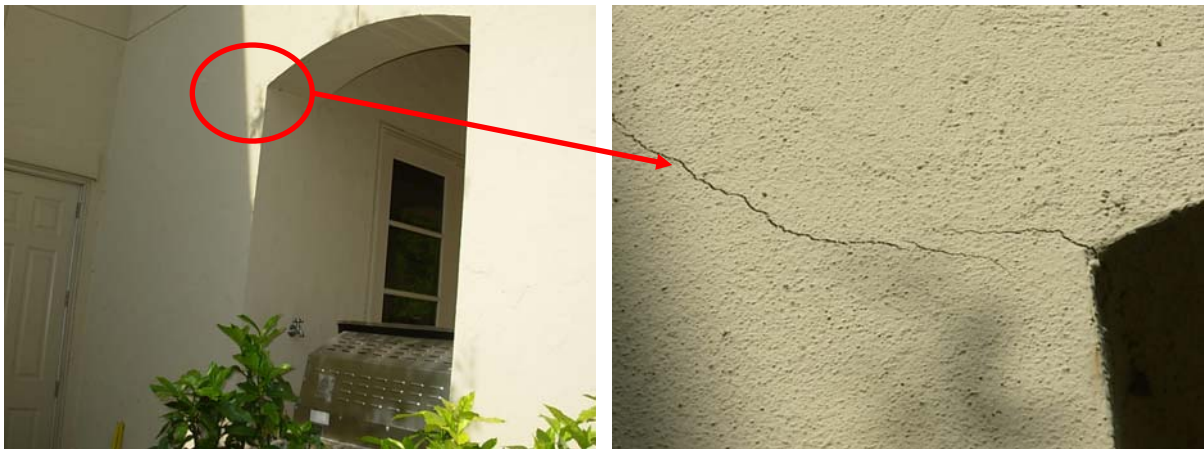
- * Cracks and/or patches were observed in the exterior stucco veneer at all four sides of the house, as seen in the photos below. The cracks in the stucco were in accordance with movement of the foundation as seen in the elevation survey at the end of the report.

Due to the more than acceptable amount of movement of the foundation of this structure, it is our opinion that repair to the foundation is needed at this time. It is recommended that at least three foundation repair contractors be contacted in order that they may make their own assessment of the scope and cost of the work needed to bring this foundation back to an acceptable degree of levelness.

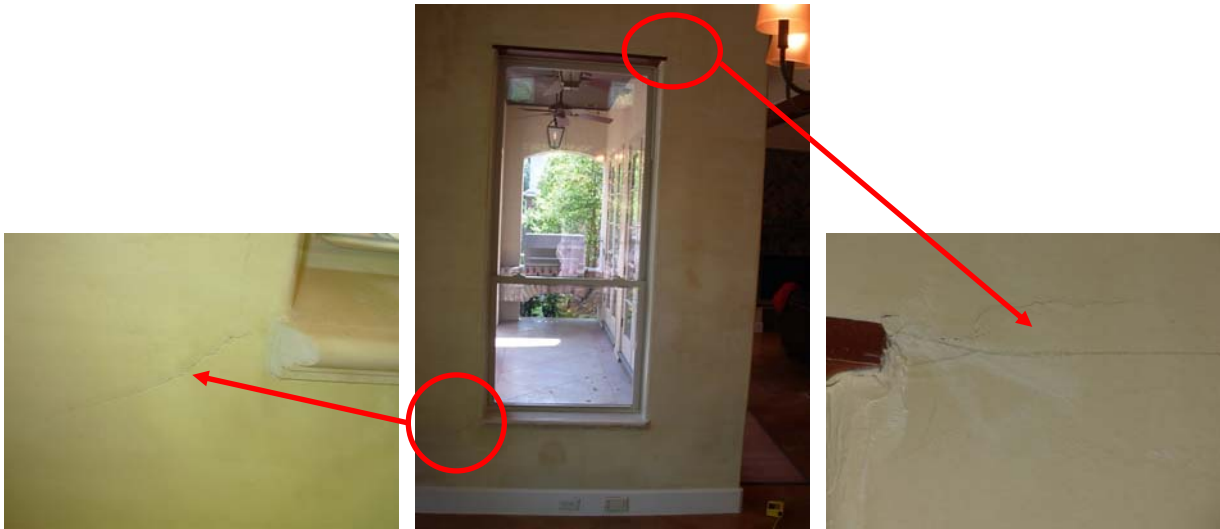
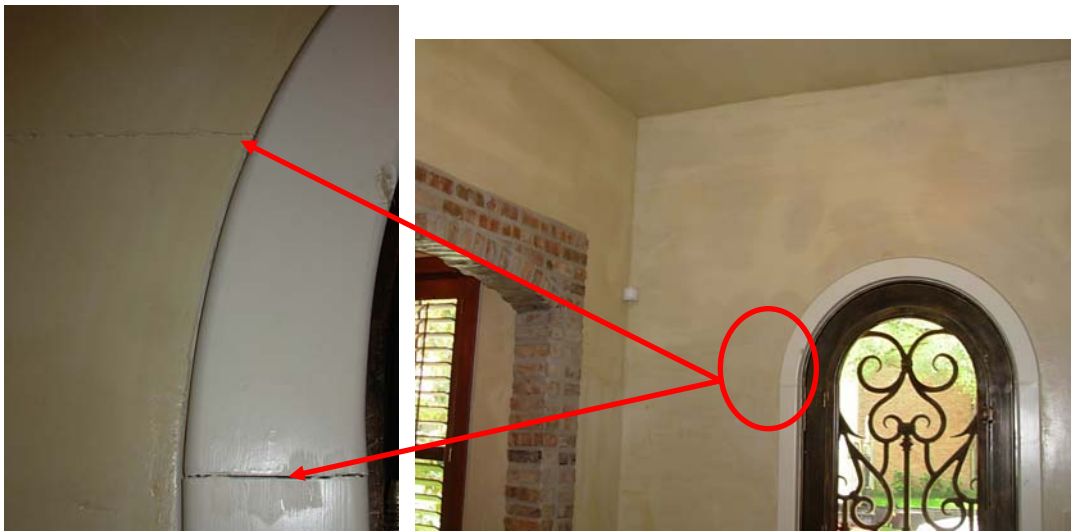
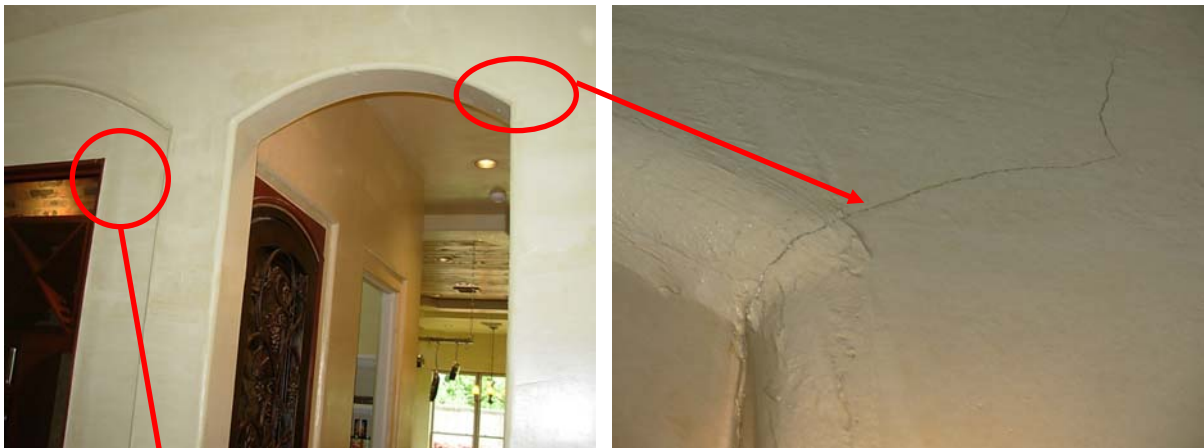
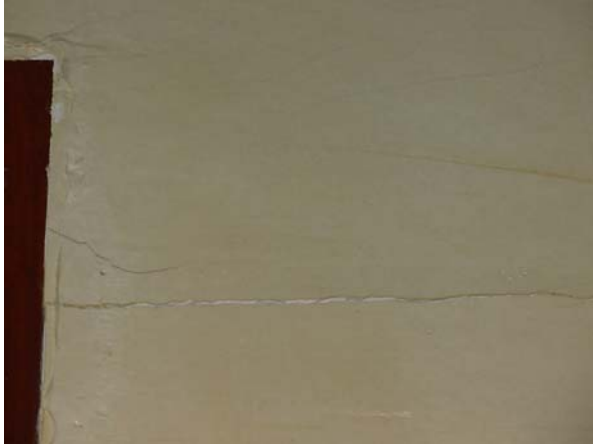
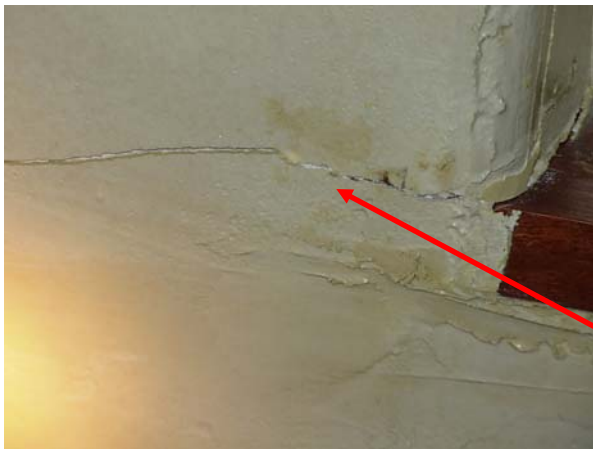
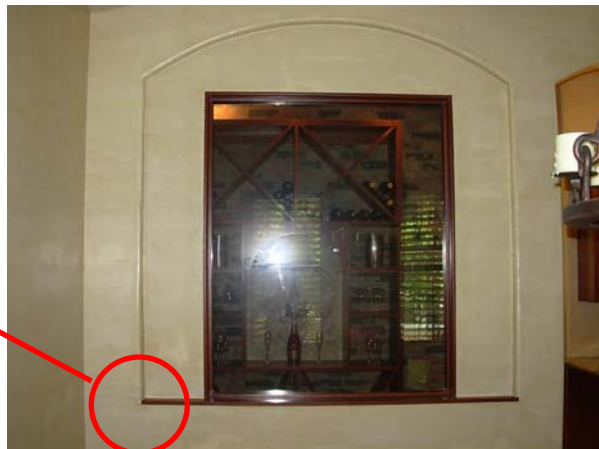
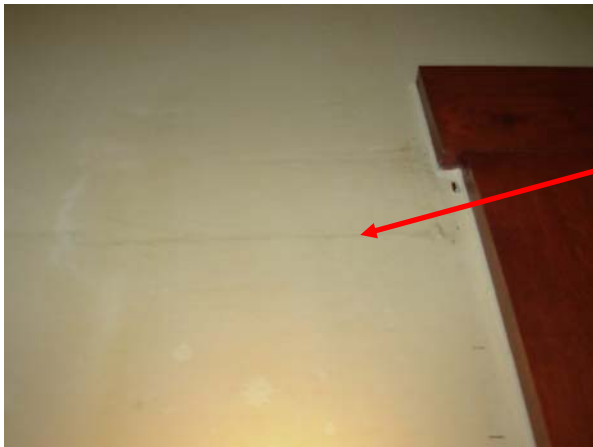
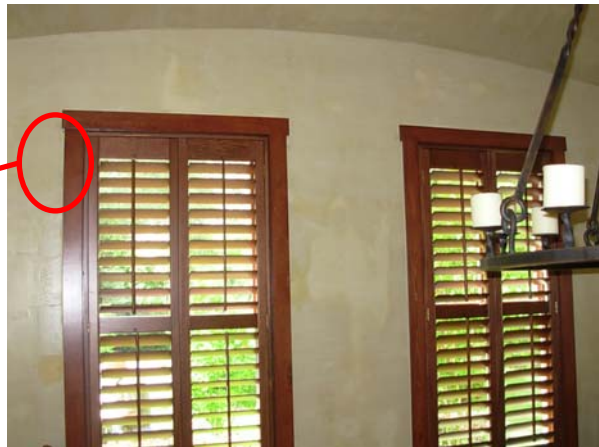
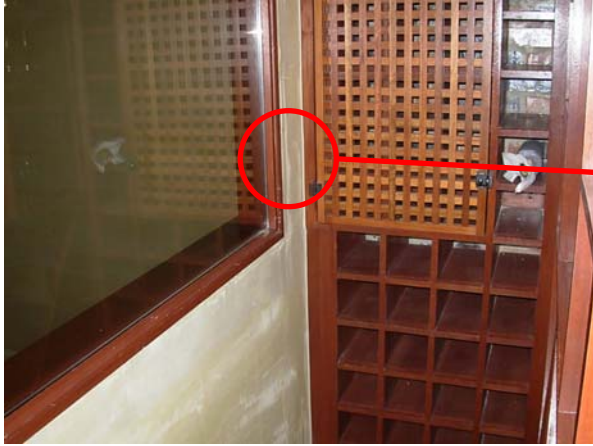
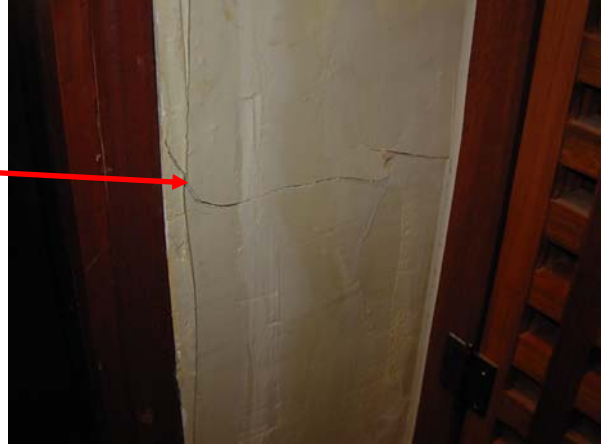
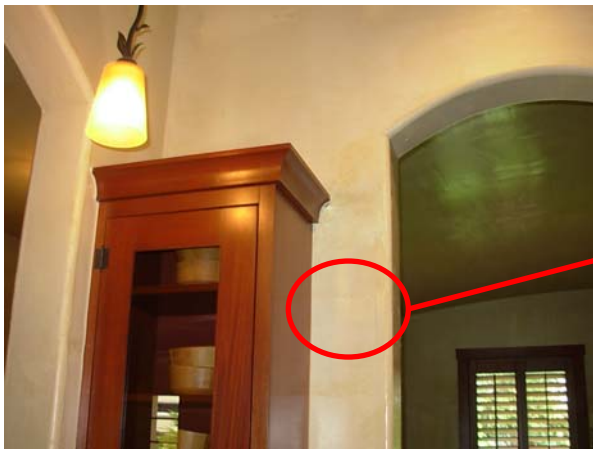
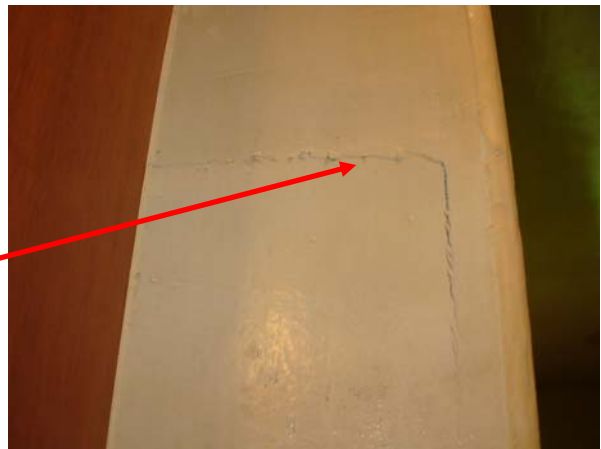
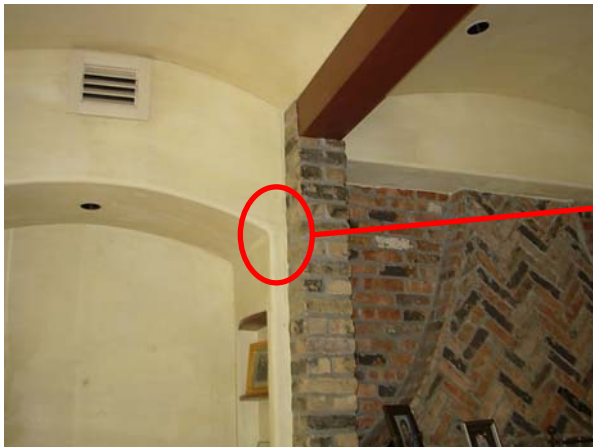
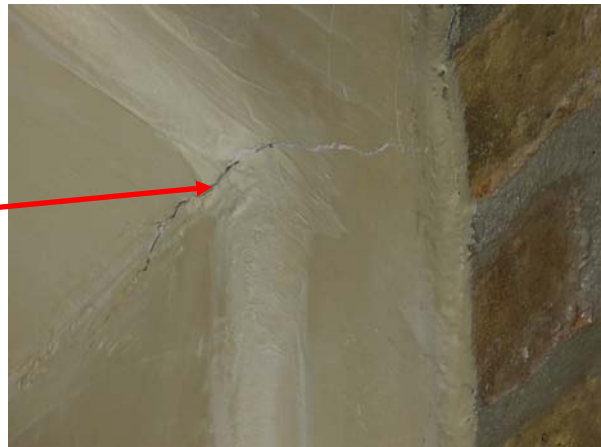
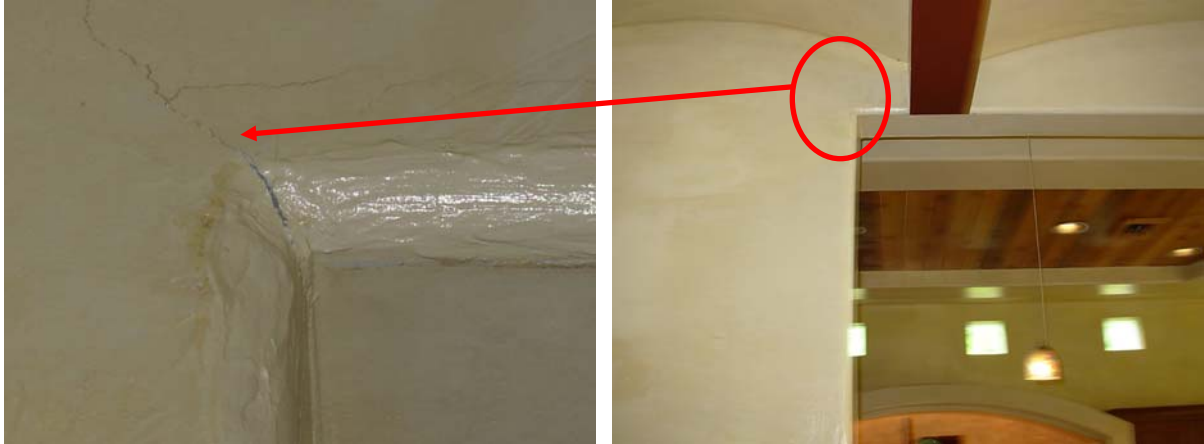
- * Sheetrock cracks, patches, or compression ridges were observed several locations as seen in the photos below. The location and direction of the cracking is in agreement with the sloping of the floors to indicate settlement of the foundation towards the low area of the house at the front wall of the study. Note that the following is only some, not all, of the cracks observed in the house.

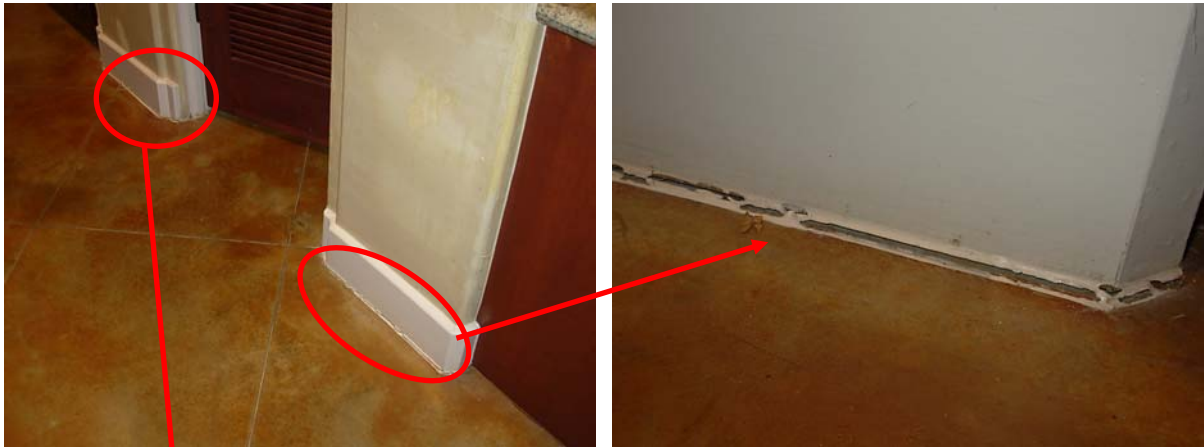
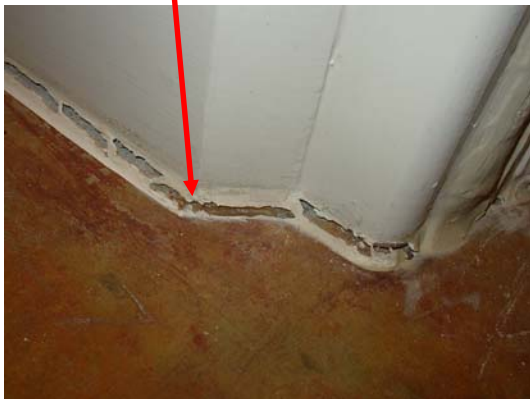
- * The foundation concrete was observed to be cracked at throughout the downstairs area and the garage, where the concrete was visible.
- * Some separations and differential movement of materials due to differential foundation movement were observed at:
 - A separation was visible at the bottom of the door trim at the kitchen pantry and wine room area.

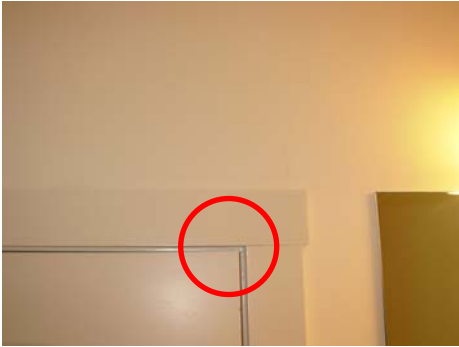
- A door was sticking at the upstairs west center bathroom.

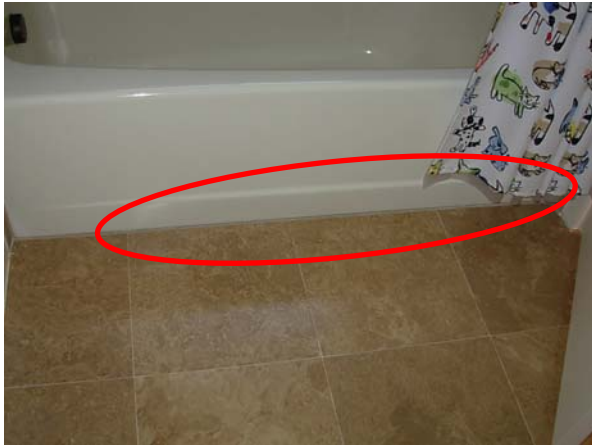
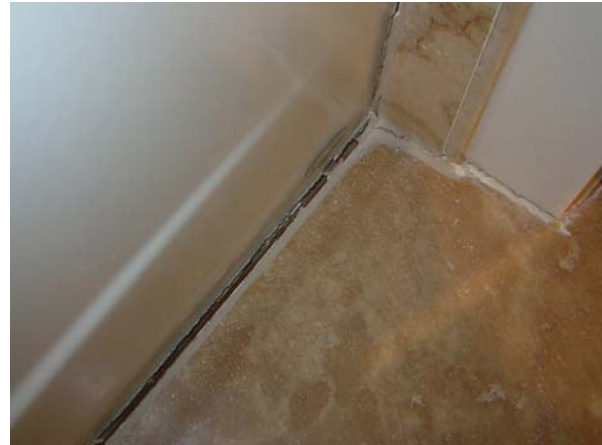
- The floor tiles at the upstairs west center bathroom were separated from the edge of the tub.

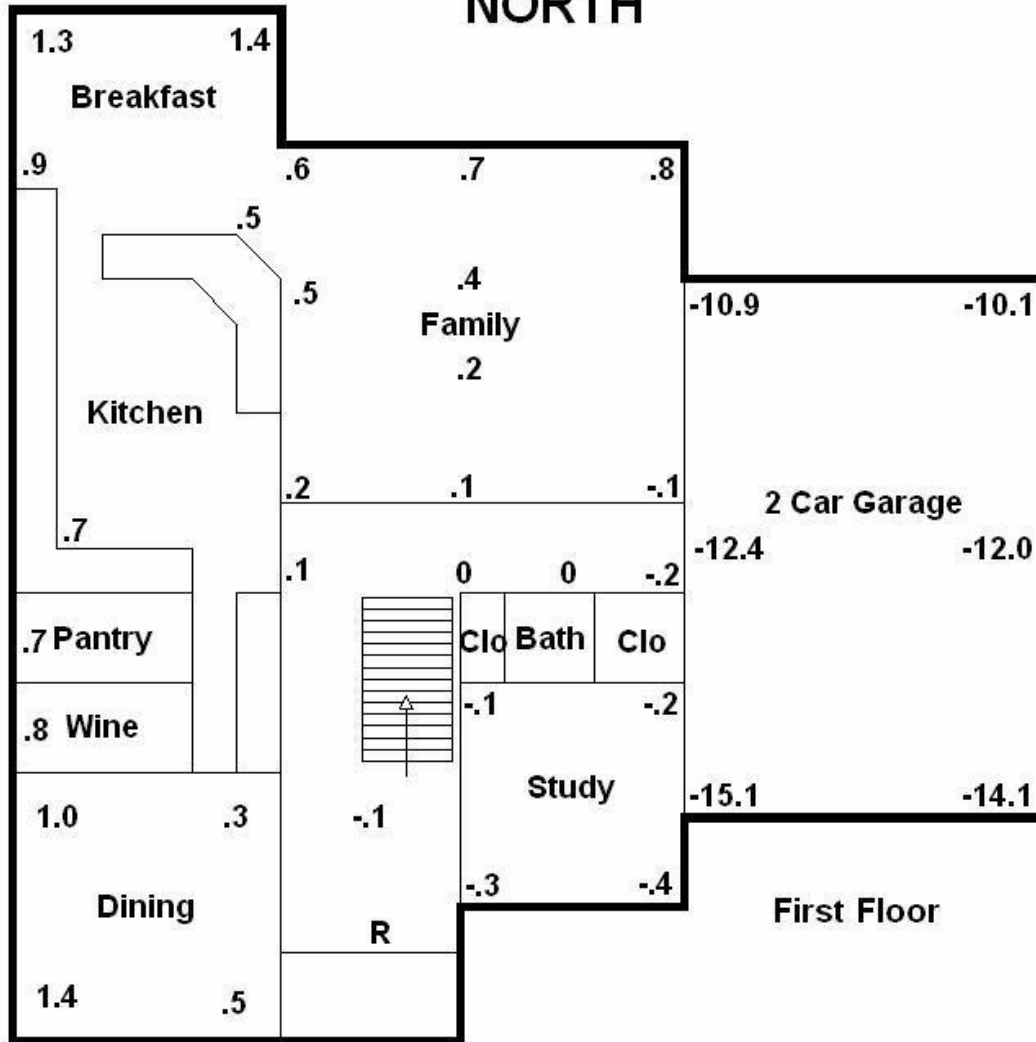
ELEVATION READINGS Property Address

- * Normally horizontal surfaces, such as floors, door tops, counters, window sills, etc., were observed to be sloping generally from the rear of the house towards a low area at the front wall of the house at the study. The floors were checked with an electronic level, and the difference in elevation between the high point and low point was 1.8 inches on the first floor and 2.2 inches on the second floor.

See our field sketch showing the elevation readings at the end of this report. Note that the "R" on the sketch is our randomly chosen starting reference point, where the elevation is 0, and all other elevation readings are taken relative to the reference point, and are measured in inches to the nearest 1/10 inch. Note also that elevation

readings taken at the garage area are relatively large numbers relative to the reference point due to the step down into the garage area.
