HEDDERMAN ENGINEERING, INC.

REF: CONDITION OF PROPERTY SURVEY

At your request, a visual survey was made of the structural components of the house located at Houston, Texas, by Tim Hedderman.

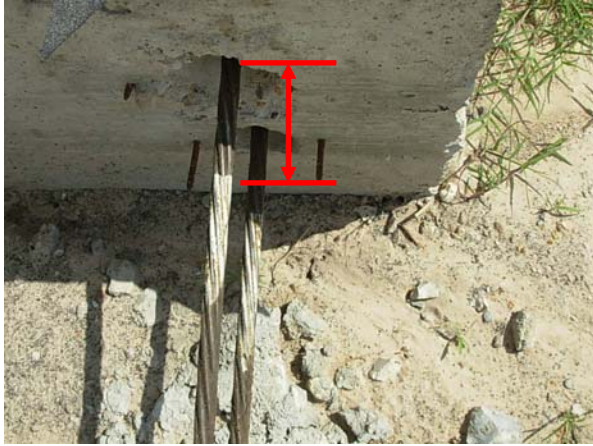
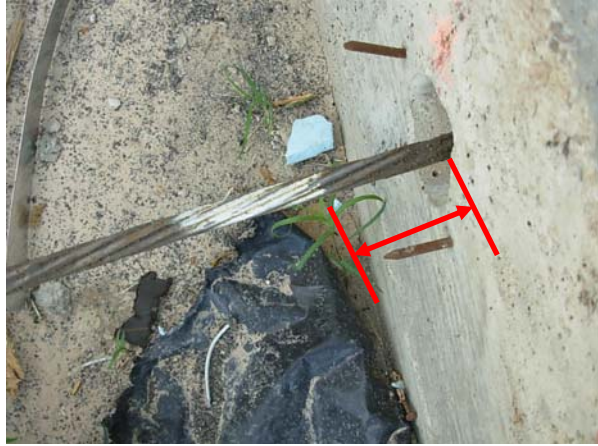
The post tension cables have been tensioned, and the anchor wedges installed. You can see in the photos below from the white paint mark on the cable, that the cables have been elongated approximately 4-5 inches during the tensioning process. When the wedges are set and the pulling force on the cable is released, the residual compression in the cable provides the reinforcement for the concrete slab.

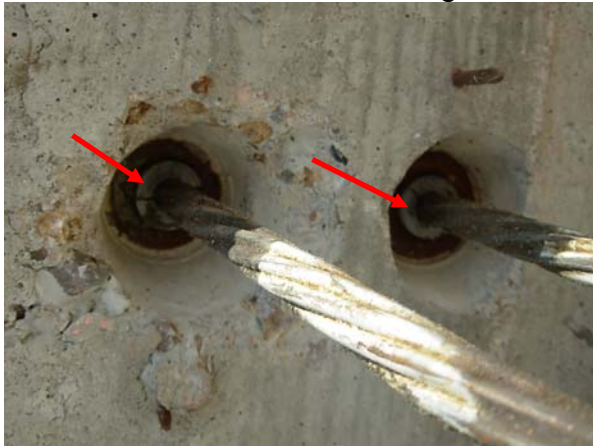
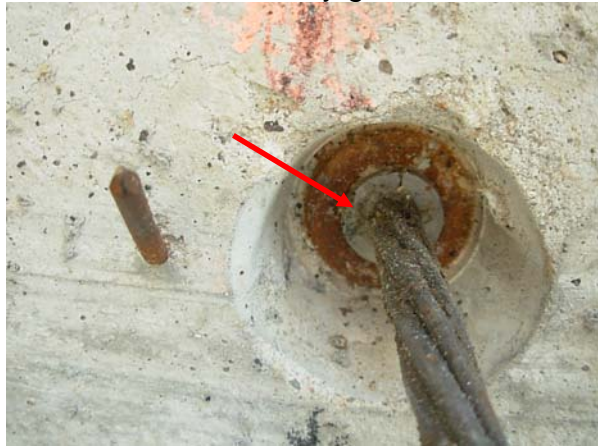
We observed that the ends of the post tension cable have not been cut off, nor have the pockets in the concrete grade beam been grouted.

Photos of the anchoring wedges installed in the anchor. The cable ends will be cut off inside the face of the concrete grade beam, and will be covered by grout.

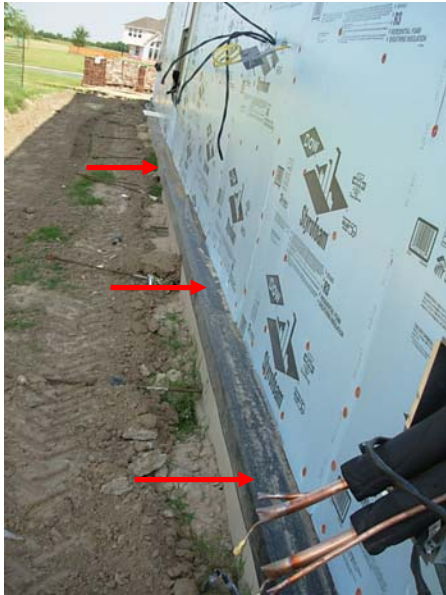
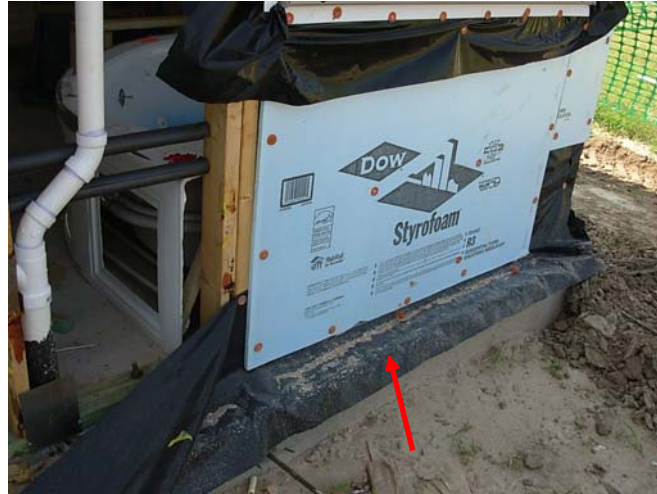
We observed that a piece of black plastic has been installed and is properly covering the brick ledge where the bricks will be installed on the foundation. The plastic is needed as a bond breaker between the brick mortar and the concrete foundation.

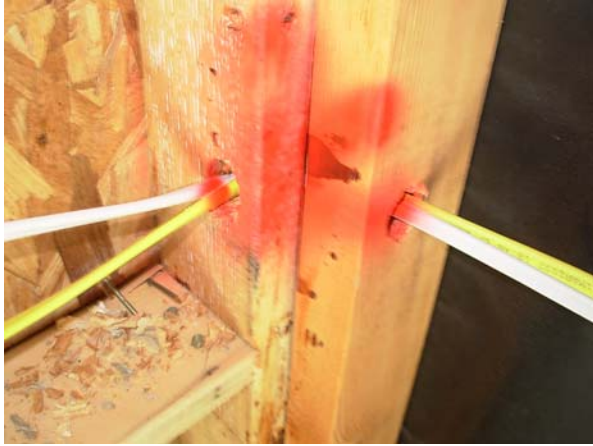
1. We observed that many of the metal nailing plates were missing from the wall studs where the electrical wiring was closer than one inch to the surface of the stud. This can allow a sheetrock screw to penetrate the wiring, and metal plates need to be installed to protect the wiring. The electricians were present at the time of the inspection, and were installing the plates.

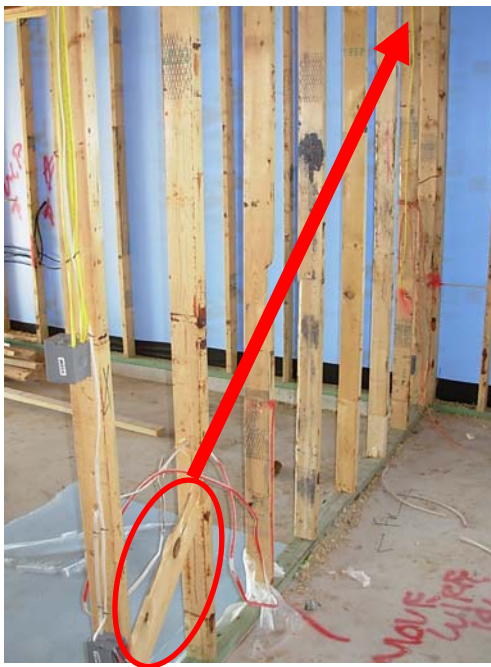
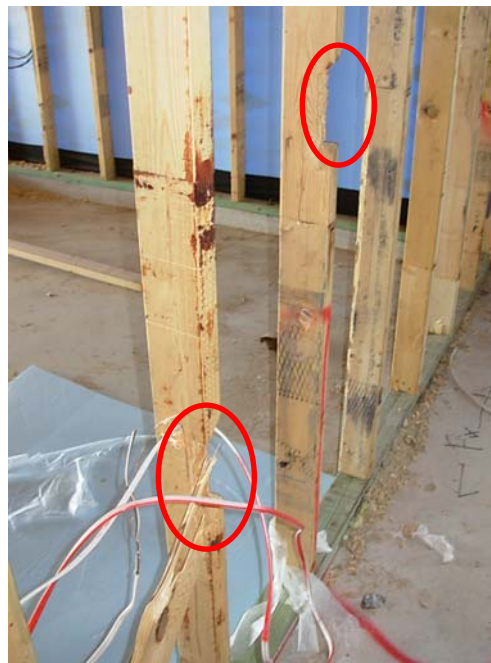
2. We observed in the bedroom between the garage and the master bedroom closet that a diagonal brace has been removed, and some of the studs that were notched out have been replaced. Further investigation with the builder is needed concerning the missing diagonal brace, which is an important framing member, and why it has been removed. (see photos below)

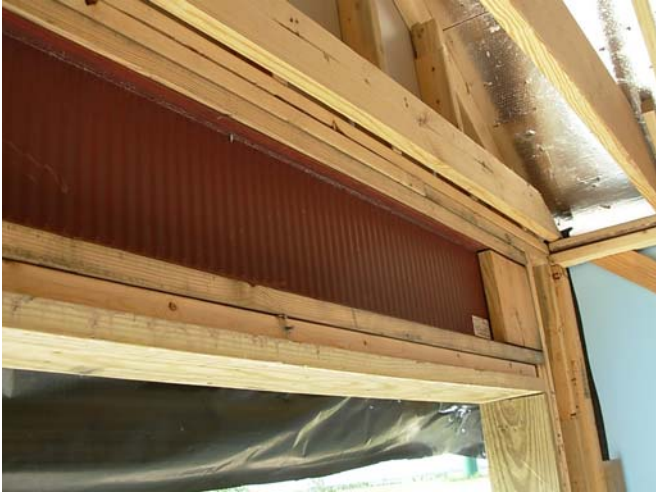
3. We observed a steel beam has been installed in the garage over the garage door, to be used at the header over the garage door. This is better and stronger than the normal beams that are installed over garage doors, and will prevent sagging of the header. (see photo below)

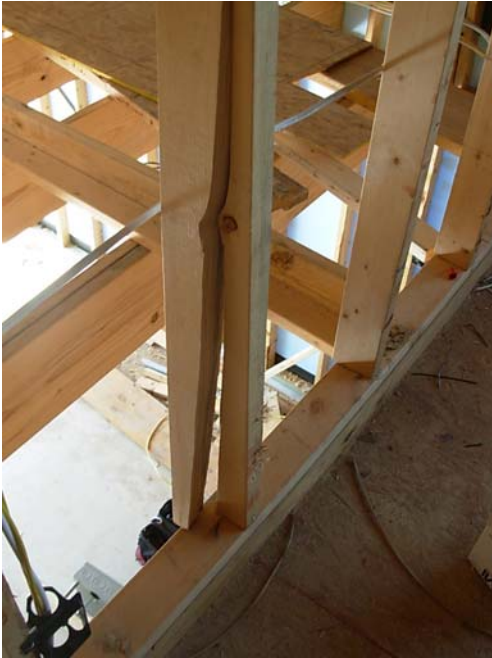
4. One of the wall studs was broken, and needs to be replaced, at the upstairs game room.

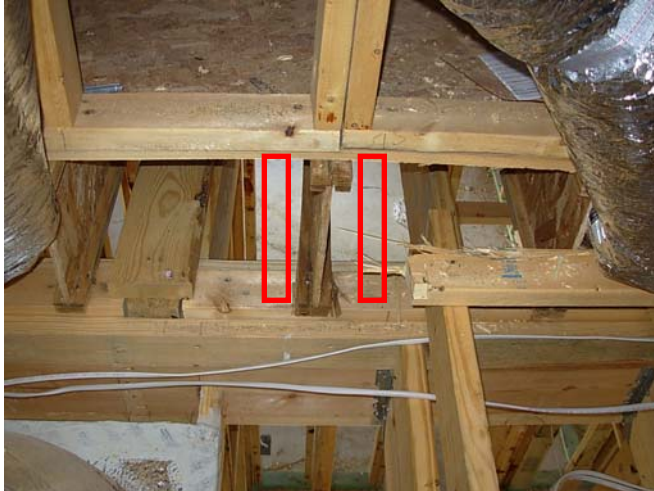
5. The prefabricated truss joists did not have 2 x 4 squash blocks installed on both sides of each truss joist, where there is a load from a wall above. Further investigation with the manufacturer of the truss joists is recommended to determine if their system requires squash blocks at these locations. Squash blocks are pieces of 2 x 4 that are 1/16 inch longer than the height of the truss joist, and are nailed to either side of the truss joist to help carry the load from the wall above, and transfer the load to the framing below.

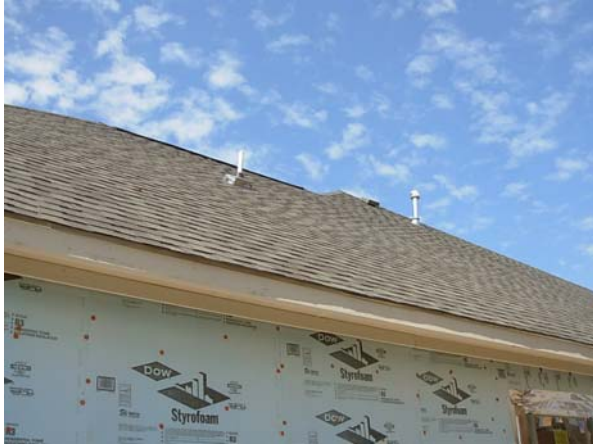
The PVC plumbing vent pipes that protrude through the roof jacks on the roof need to be painted to prevent deterioration of the PVC from the sunlight. Also, the metal vent pipes

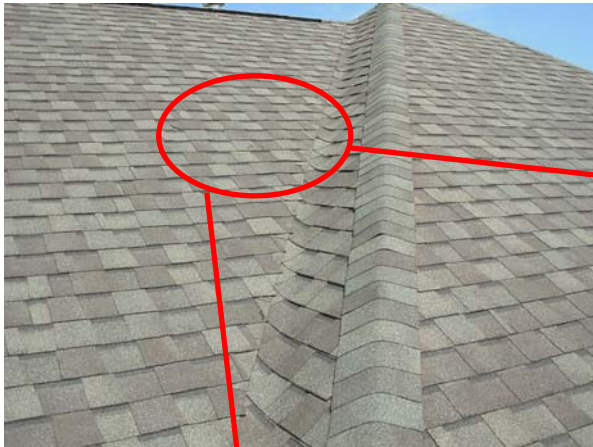
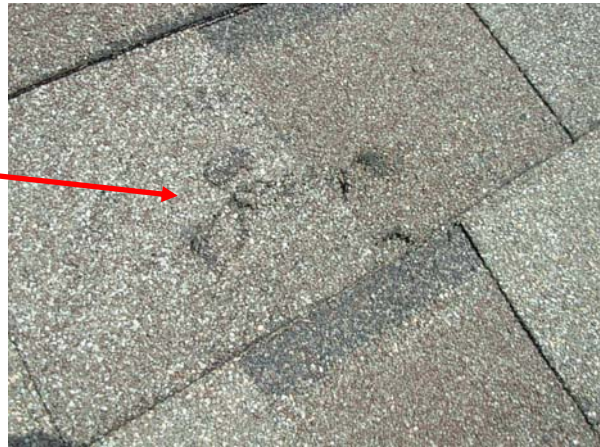
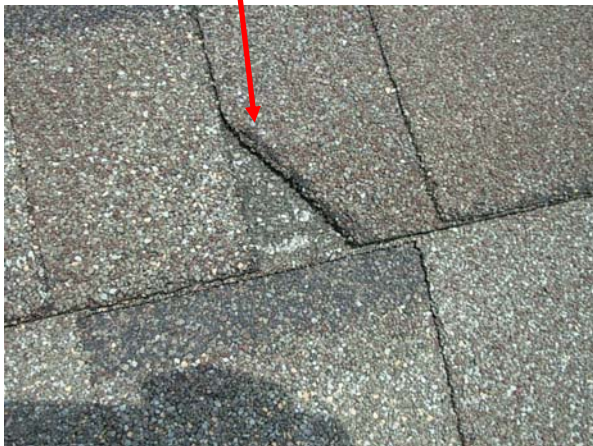
We observed a damaged shingle on the front elevation of the roof, and the damaged shingle needs to be replaced before it causes a roof leak.

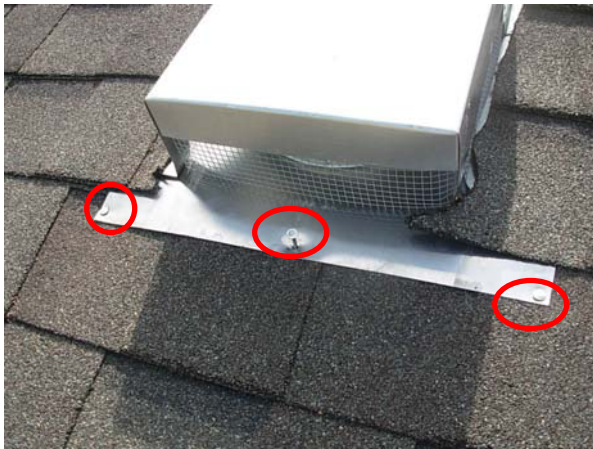
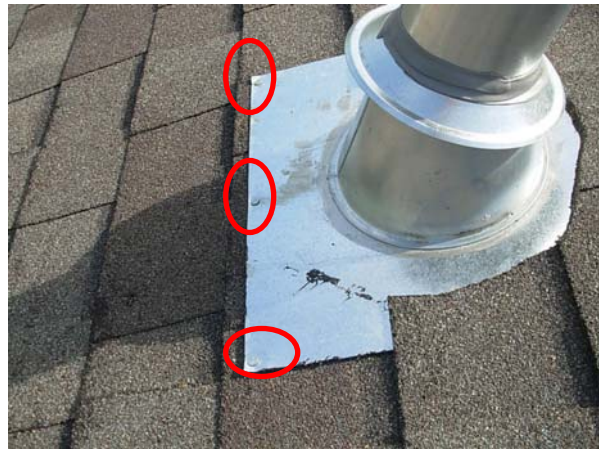
Some of the flashing on the roof jacks were not sealed at the nail heads, and caulking needs to be applied to the nail heads to prevent roof leaks. Most of the nail heads on the other flashings and roof jacks were properly sealed. (see photos below)

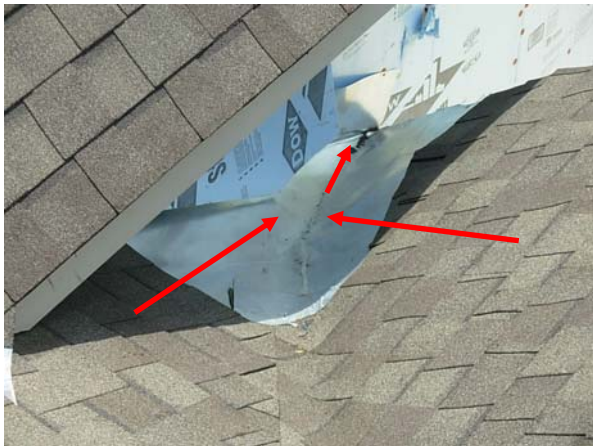
We observed a valley at the front part of the roof that narrows down, and will have a tendency to trap leaves and other debris. The area needs to be maintained to prevent a build up of debris. The area was flashed with metal flashing, which will help to prevent leaks in the area.

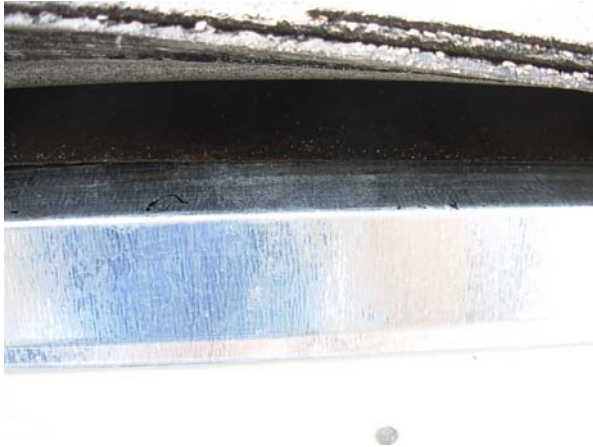
We lifted the edge of the shingles to verify that the tar paper underlayment was properly lapped on top of the drip edge flashing, and it was. No repairs are needed.

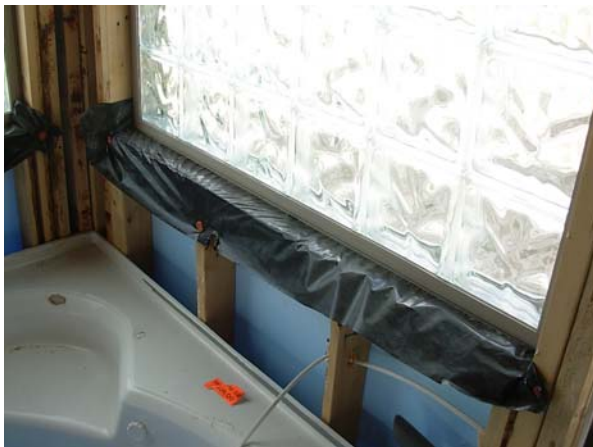
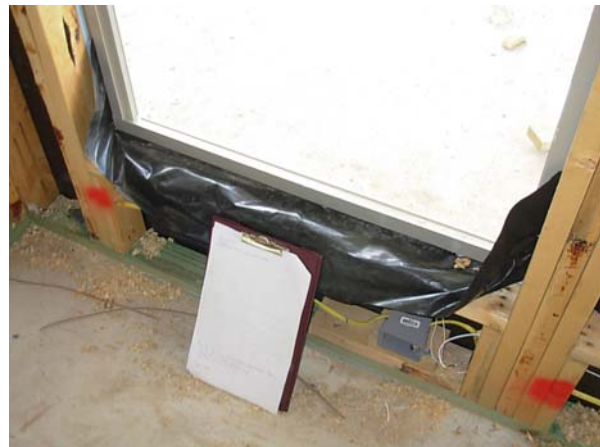
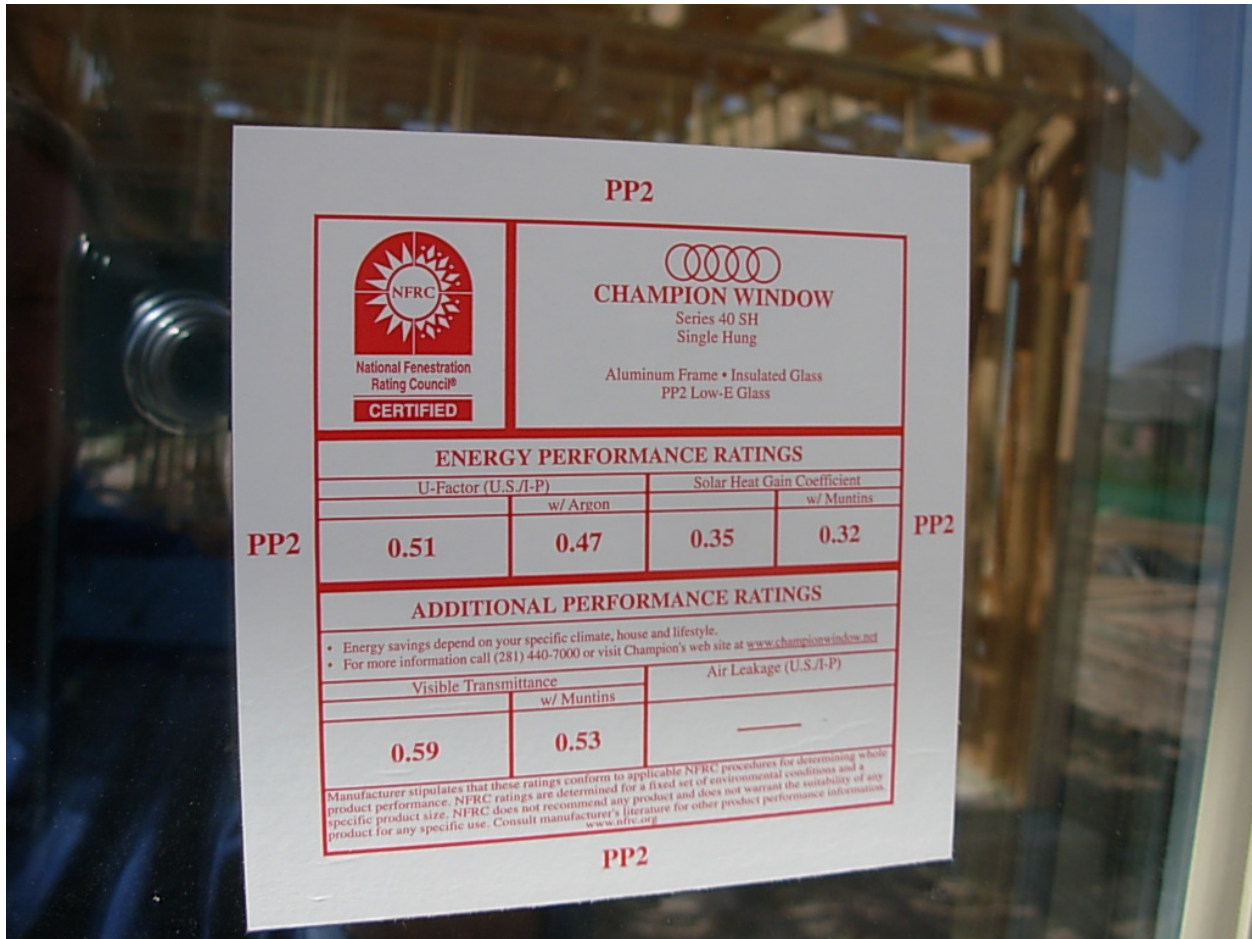
Most of the windows in the house have had a piece of plastic installed under the window, and wrapping over the window sill. This is to prevent any water that leaks through or around the window from going to the inside wall cavity, but rather routes the water to the outside of the wall. The plastic laps over the outside of the window sills, and the windows were sealed with Window Wrap tape.

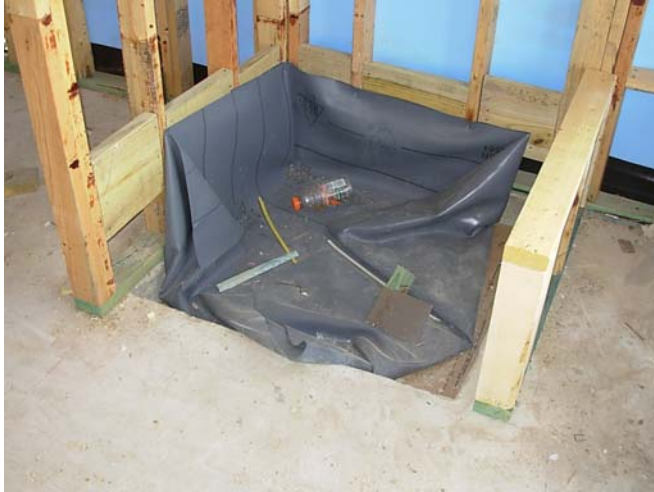
The shower stall at the master bathroom has not been constructed at the time of the inspection, so we could not determine if the shower will have a seat built into the shower. The reason we mention this at this time is because it has been our experience that these seats are not typically built with a watertight detail, where the shower pan material extends across the bottom of the shower, and up over the seat detail. Without the shower pan material covering the seat, water will get under the tile or synthetic marble covering when the grout or caulking deteriorates, and will cause a leak. It is recommended that you check with your builder to determine if a seat will be installed in the shower, and to verify that he intends to extend the shower pan material up over the seat to make a watertight detail. (see photo below)

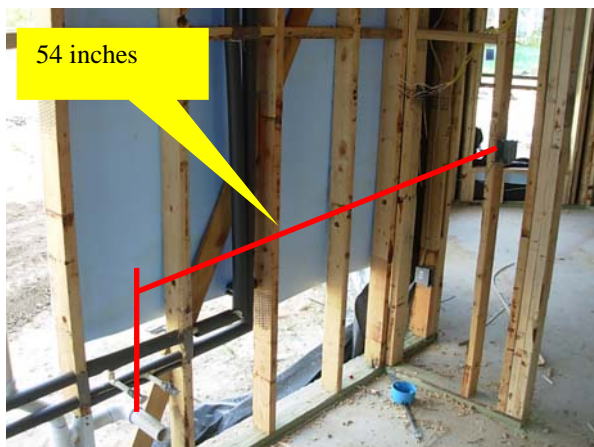
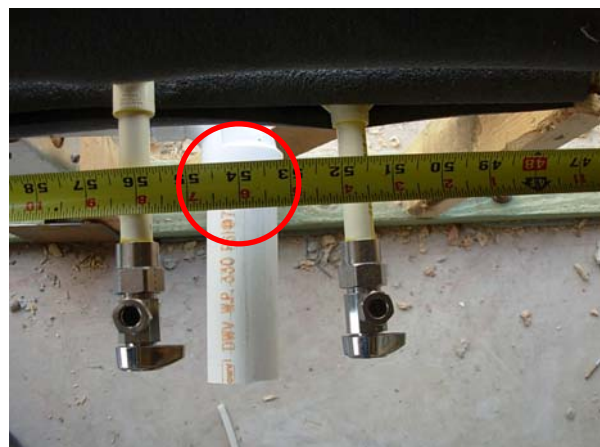
The outlet in the master bathroom was located 54 inches from the centerline of the sink on the adjacent wall. Bathroom outlets are required to be no farther than 36 inches from the outside edge of the sink. Further investigation with your builder is recommended.

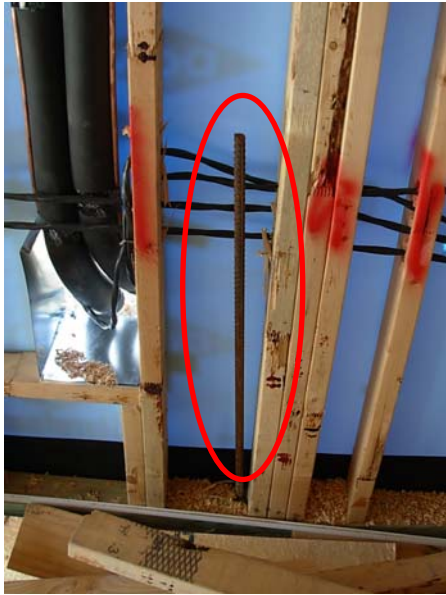
The required reinforcing steel stub up was observed in the garage, where a piece of rebar from the foundation is extended up into the garage wall. However, the bonding wire from the breaker panel to the rebar was not installed at the time of the inspection.

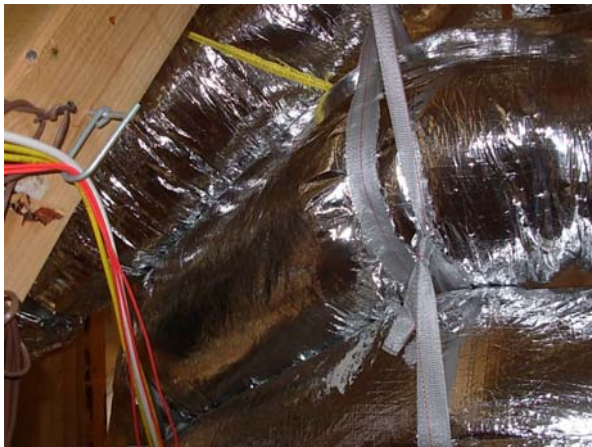
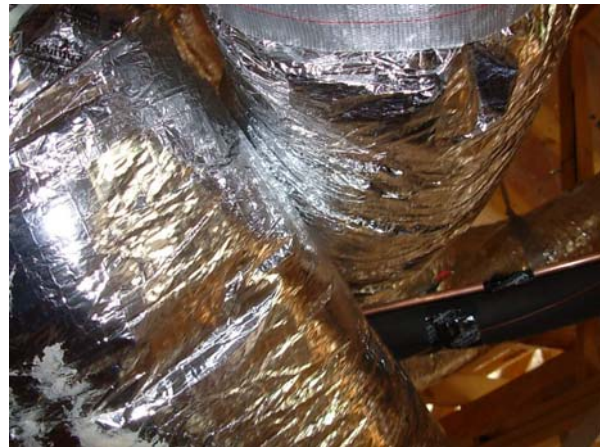
The air conditioning ductwork was in contact with each other in several places. This condition can cause condensation at the contact points and it is recommended that the ducts be separated.

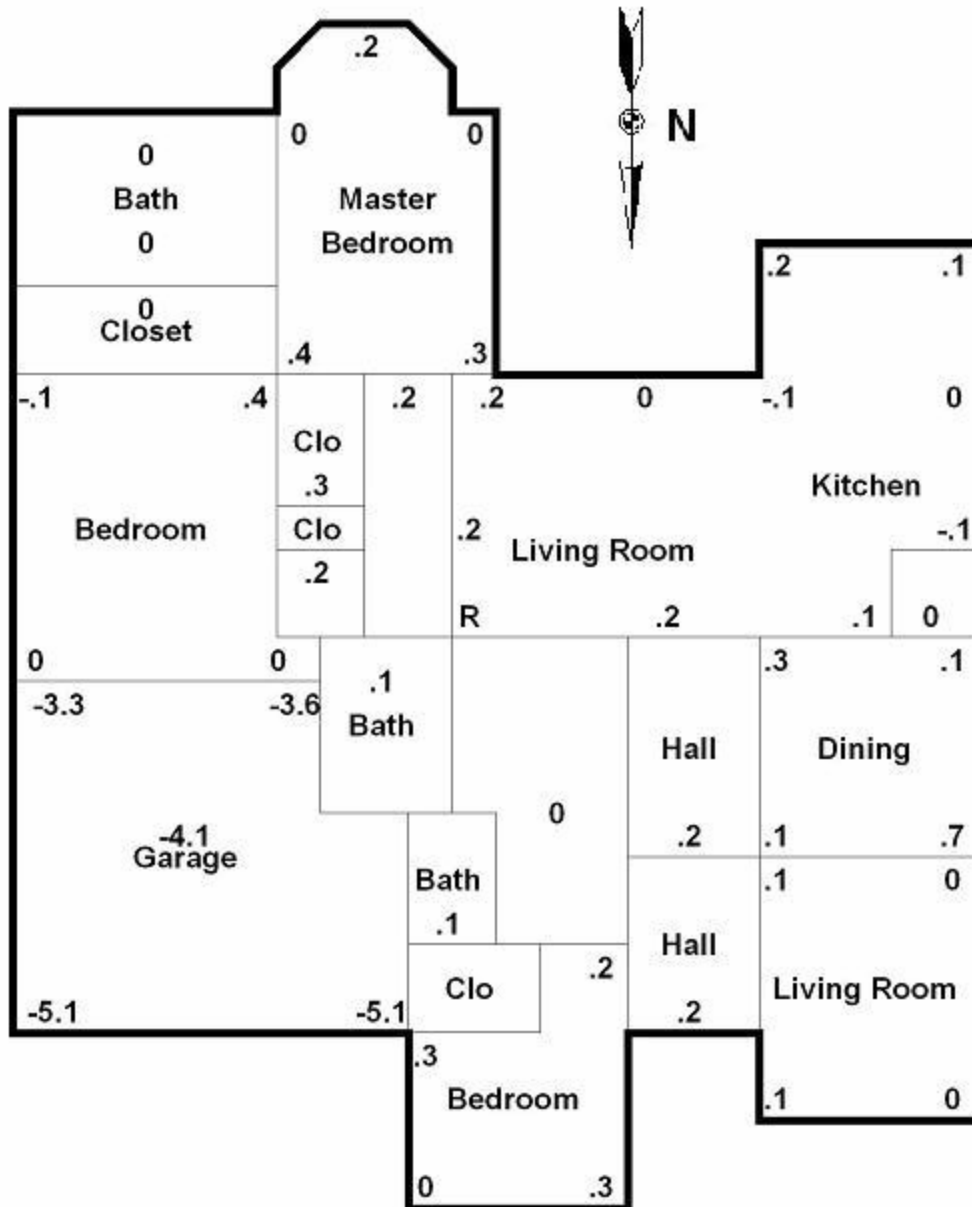
ELEVATION READINGS Property Address

Normally horizontal surfaces, such as floors, door tops, counters, window sills, etc., were observed to be acceptably level throughout the house. The floors were checked with an electronic level, and the difference in elevation between the high point and low point was 0.8 inch. The high point was located at the west side of the house at the dining room, and the low point was located on the east side of the house at the center bedroom.

See our field sketch showing the elevation readings at the end of this report. Note that the "R" on the sketch is our randomly chosen starting reference point, where the elevation is 0, and all other elevation readings are taken relative to the reference point, and are measured in inches to the nearest 1/10 inch. Note also that elevation readings taken at the garage area are relatively large numbers relative to the reference point due to the step down into the garage area.
