PROPERTY INSPECTION REPORT

I. STRUCTURAL SYSTEMS

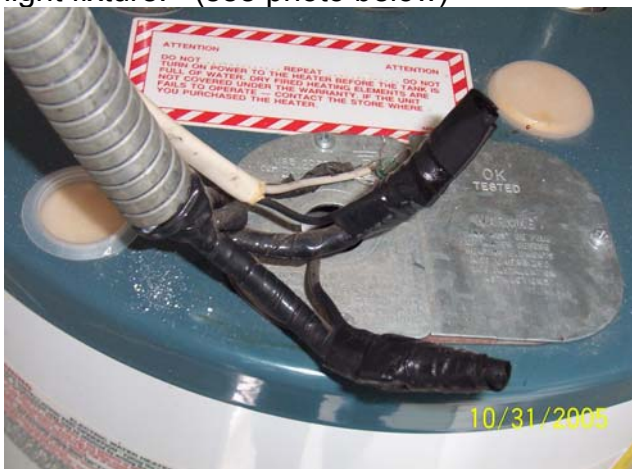
Wires that were spliced and were not in a junction box were observed at the water heater. (see photo below) \$ 50

The light in the west exterior closet was tied to the water heater power supply and grounded to the water heater. This is a dangerous condition. Have an electrician make the proper connection to supply power for the \$100

light fixture. (see photo below)

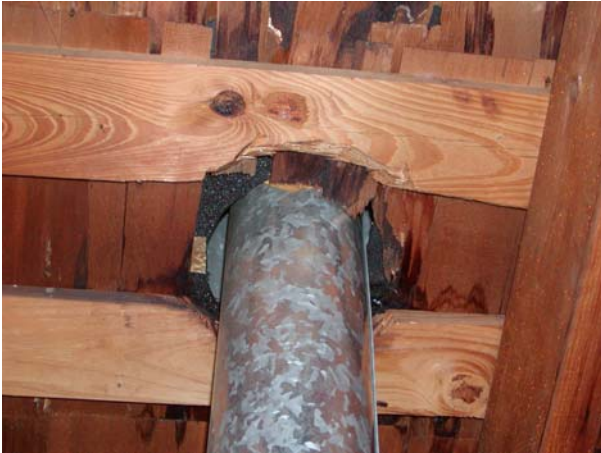
Furnace Vent Pipe

Double wall vent pipes require a minimum of one inch clearance to any material that is combustible. The vent pipe was located too close to a combustible material, which is a fire hazard. (see photo below) \$ 50

Furnace vent pipe in contact with wood roof

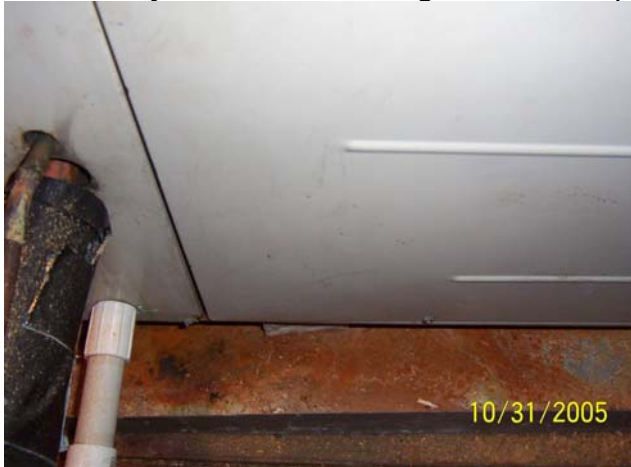
The overflow pan under the evaporator coil had rust in the pan, apparently from water overflowing the condensate drain line into the overflow pan. No water was in the pan at the time of the inspection, but, since we only ran the unit for a few minutes, it is recommended that the drain line be

checked by an air conditioning service company.

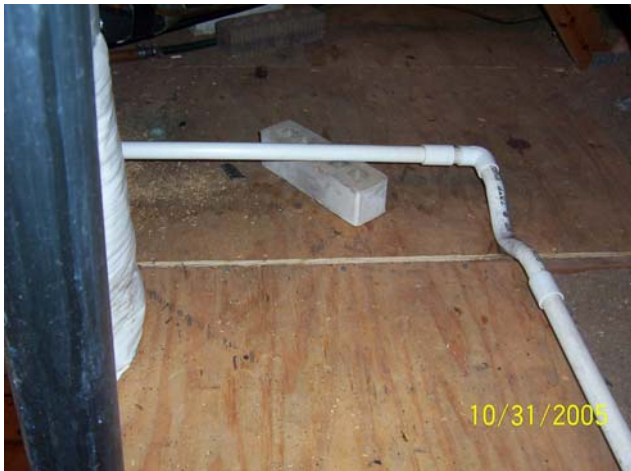
The primary condensate drain line was not insulated, and can cause the drain line to "sweat" and drop water to the ceiling below. The drain line should be insulated for the first 10 feet to prevent condensation.

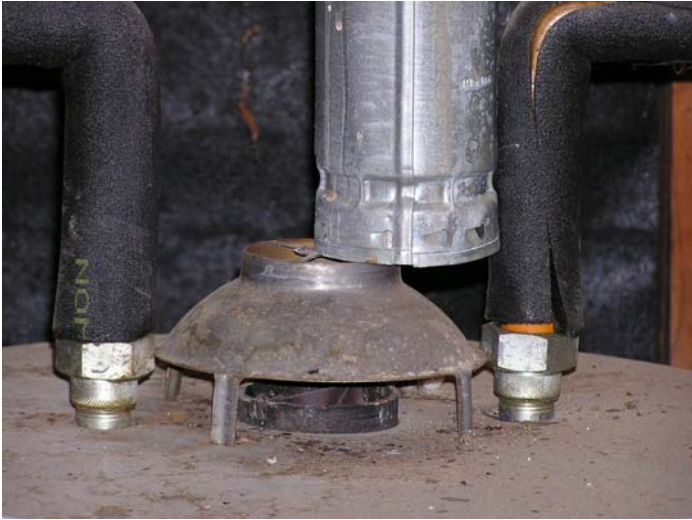
Vent Pipe

The water heater vent pipe was disconnected from the baffle, which can allow hazardous combustion gases to vent into the attic. \$ 50
Have the vent pipe properly resealed over the baffle.

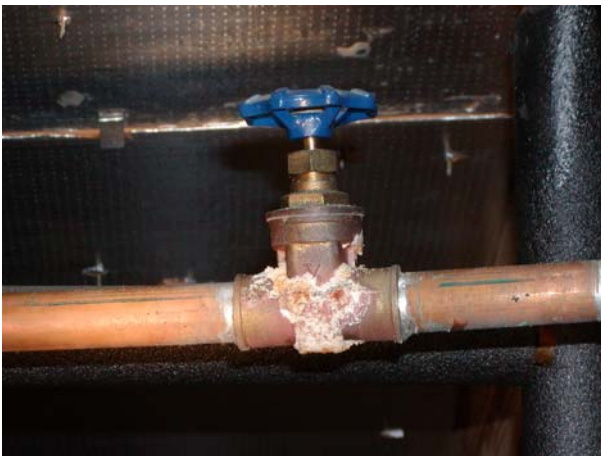
Water Heater Plumbing

The brass shut off valve on the inlet water line was badly corroded, and needs to be replaced before it starts leaking. Obtain Estimate
