HEDDERMAN ENGINEERING, INC.

REF: CONDITION OF PROPERTY SURVEY

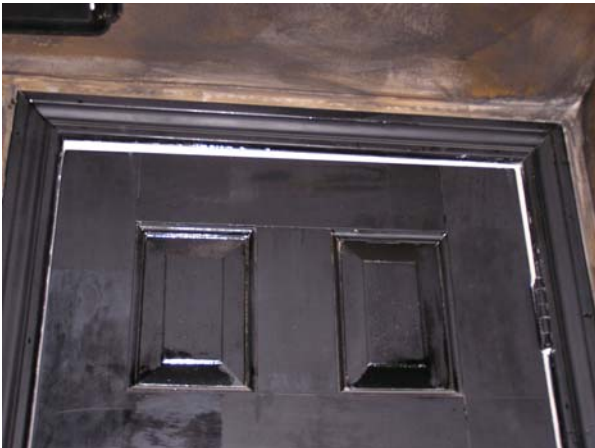
- * Cracks in the exterior brick veneer were minimal in number and degree.
- * Sheetrock cracks, patches, or compression ridges were observed at the living room.
- * The foundation concrete was observed to be cracked at the garage floor.
- * Some separations and differential movement of materials due to differential foundation movement were observed at:
 - Window frames were separated from the exterior brick veneer at the south side of the house, and the separations have been sealed.
 - Doors that would not latch due to misalignment of the striker plate and the locking mechanism were observed at the half bathroom.
 - Door frames that were out of square, leaving a triangular separation between the door and the door frame at the top of the door were observed at the half bathroom, where a separation of approximately $\frac{3}{4}$ - 1 inch was visible at the top of the door.

Due to the more than acceptable amount of movement of the foundation of this structure, it is our opinion that repair to the foundation is needed at this time. It is recommended that at least three foundation repair contractors be contacted in order that they may make their own assessment of the scope and cost of the work needed to bring this foundation back to an acceptable degree of levelness.

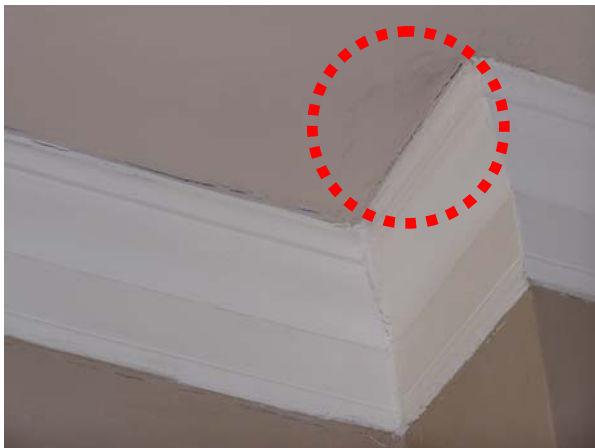
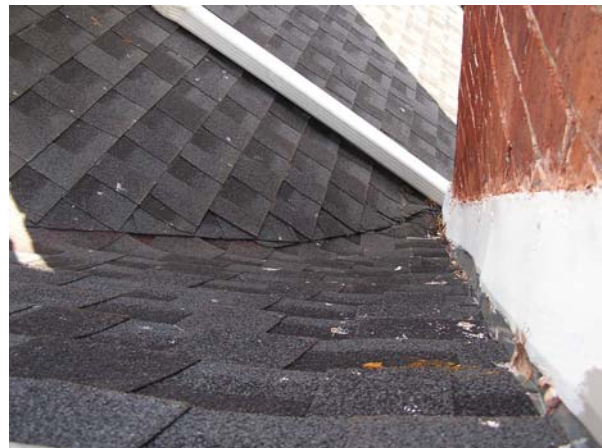
After observing the interior of the structure, evidences of current roof leaks were not visible. The absence of evidences of roof leaks does not guarantee that roof leaks were not present; rather, that no evidences of leaking were visible at the time of the inspection. Some stains were visible on the ceiling at the living room near the fireplace, but the stains appeared to be related to previous roof leaks. It is recommended that you check with the owner concerning the stains. It appears that the stains are located below a restricted valley at the chimney, where the roof narrows down, and can hold leaves and other debris. If debris is allowed to build up, it can allow a "dam" effect, causing a roof leak. Care must be taken to keep the valley clean. Also, you may want to consider having a cricked built to route water around the chimney.

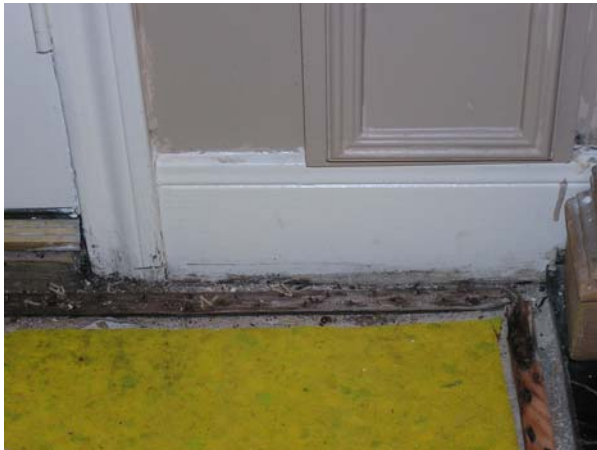
1. The exterior doors at the master bedroom, where the carpet and carpet tack strips were water stained, and the baseboard molding were water stained. (See photo below) The source of the water penetration appeared to be

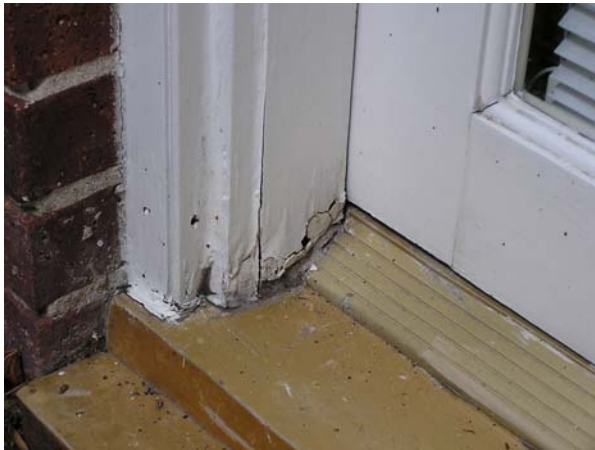
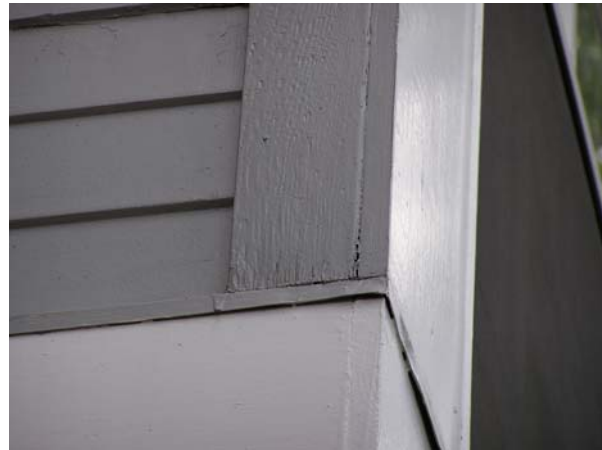
Wood rot was observed at several locations around the house, including at the garage door trim; the front door trim and threshold; the exterior doors at the master bedroom, the living room, and third floor; the window trim at the front of the house at the master bedroom; and the wood trim at the front of the house at the second floor window boxes. It is pointed out that additional damage could be present under the rotted materials, that will not be visible until the outer rotted materials are removed. Have a service company determine the entire scope of wood rot throughout the house, and provide a cost estimate to replace all rotted wood. (see photos below)

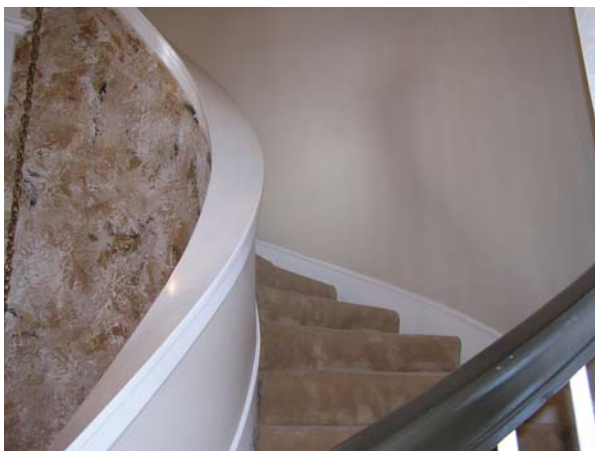
The handrails for the stairway were not constructed according to the current building code standard, which can be hazardous for someone using the stairs. It is recommended that you consider having an approved handrail installed. Obtain Cost Estimate. (see photo below)

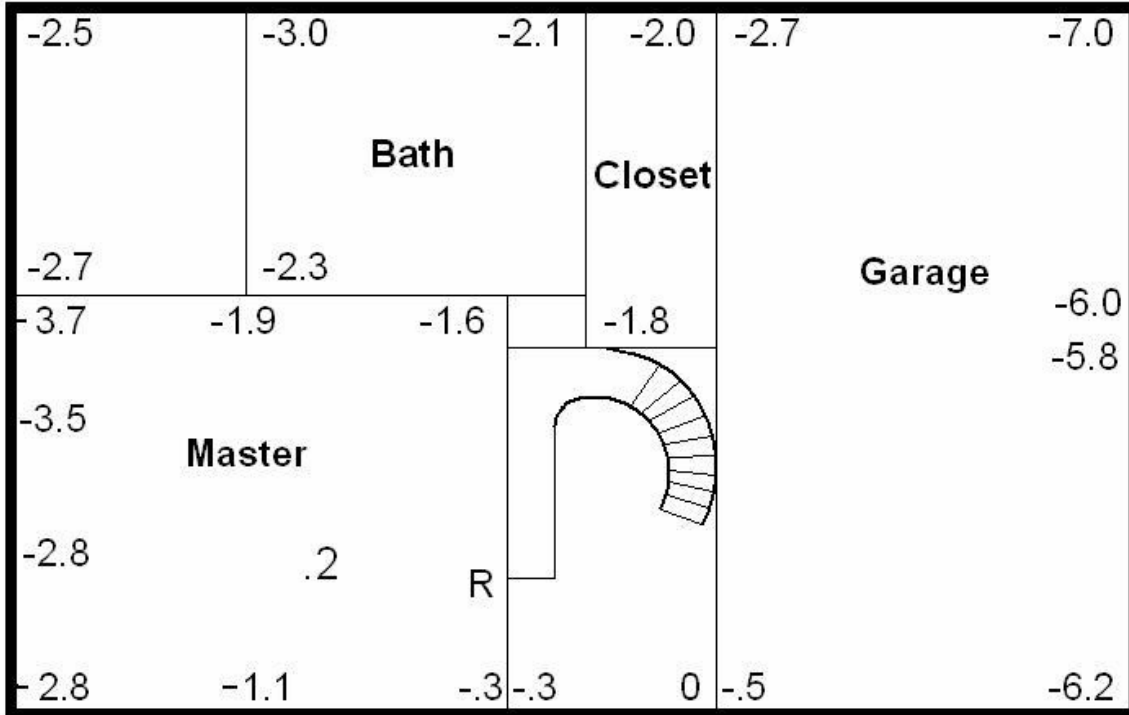
ELEVATION READINGS

- * Normally horizontal surfaces, such as floors, door tops, counters, window sills, etc., were observed to be sloping generally from a high point just inside the door of the master bedroom, towards the front, rear, and south sides. The floors were checked with an electronic level, and the difference in elevation between the high point and

low point was 3.9 inches. The lowest point was located at the rear corner of the master bedroom, and the floor in the master bedroom had a noticeable unlevelness when walked upon. See our field sketch with the elevation readings at the end of this report.
