PROPERTY INSPECTION REPORT

I. STRUCTURAL SYSTEMS

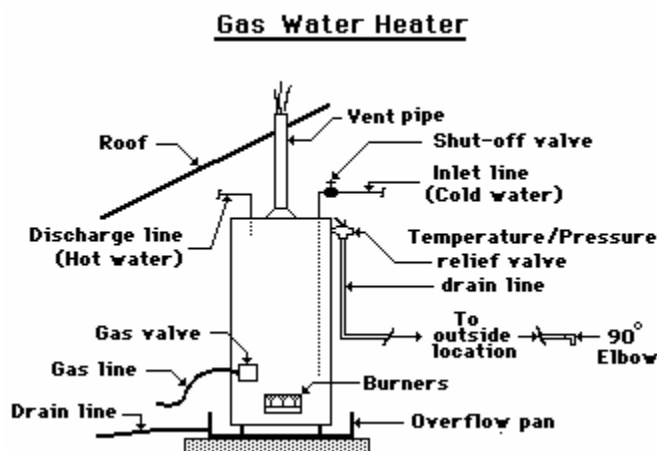
<u>Manufacturer</u>	<u>Size</u>	<u>Date</u>	<u>Piping Type</u>	<u>Location</u>
State	50 Gallon -Gas	2000	Copper	Attic

No items requiring repair were visible at the time of the inspection for the heating operation of the electric water heater. The unit was providing an adequate supply of hot water during the duration of the inspection. (Information) --

The drain line for the temperature/pressure relief valve was routed uphill. \$100
 It is recommended for safety reasons that the drain line be routed downhill to prevent sediment in the water from clogging the relief valve.

The water heater vent pipe was disconnected from the baffle, which can allow hazardous combustion gases to vent into the attic. \$ 50
Have the vent pipe properly resealed over the baffle.

The brass shut off valve on the inlet water line was badly corroded, and needs to be replaced before it starts leaking. Obtain Estimate

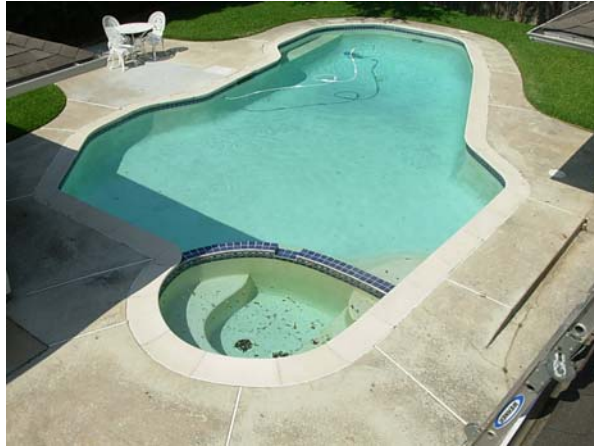
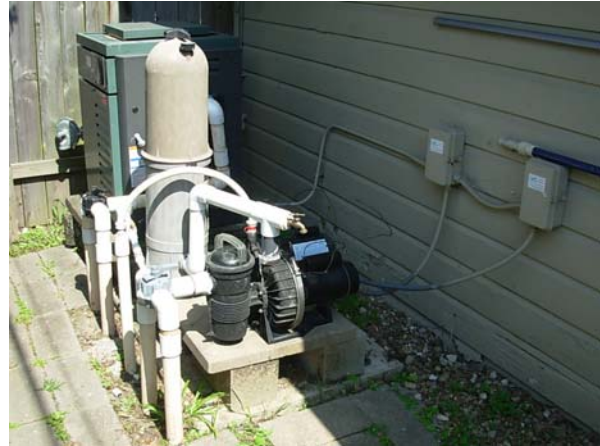
Pool Surface

The swimming pool was an in-ground concrete (gunite) pool and the pool equipment was located at the side of the house.

The surface of the pool was beginning to spall, and the plaster finish has only a limited amount of remaining life. It can be anticipated that the pool will need to be replastered in the next few years. (Information) --
